## SHORELINE LIFT STATION

# Tyler Water Utilities - Lift Station Assessment Form

Lift Station Name SHORELINE Type Submersible  
 Location/Address 4588 Cascade Shoreline Drive  
 Lift Station Asset ID \_\_\_\_\_ Number of Pumps 2  
 Firm Capacity in GPM (all pumps operating) \_\_\_\_\_  
 Firm Capacity in GPM (largest pump out of service) \_\_\_\_\_  
 Inspector Don White Date Dec 17, 2017  
 City Works Work Order \_\_\_\_\_

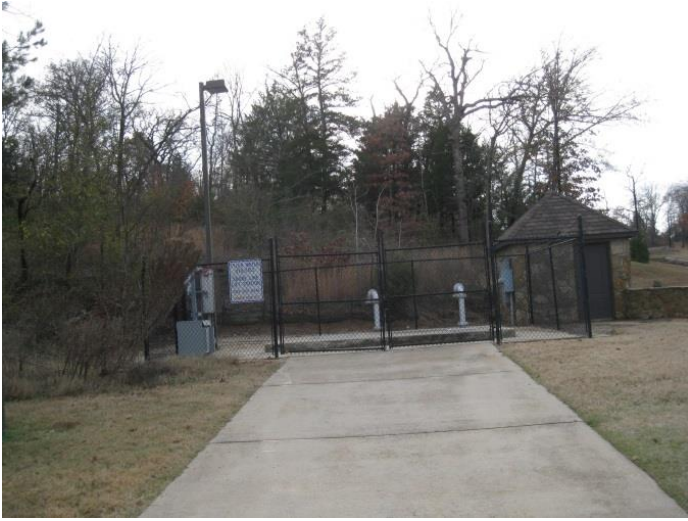
Lift Station Perimeter Facing South

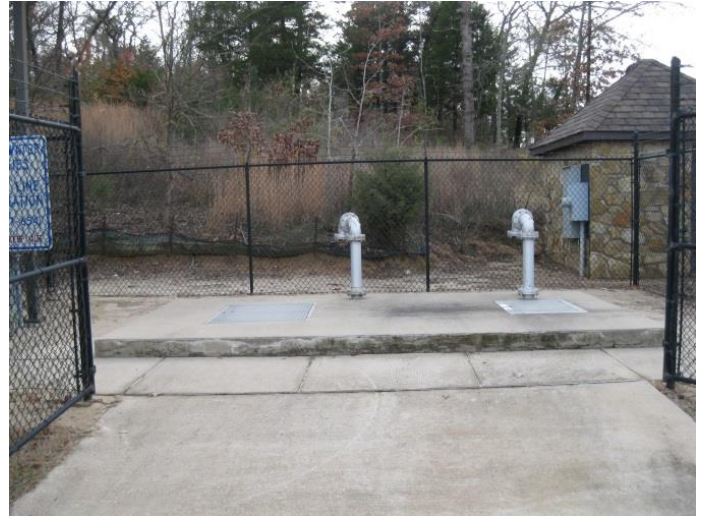
Comments Uphill slope at rear of lift station hold back with silt fence in poor condition. Erosion silt on concrete lift station surfaces wet well & valve vault slab surface +/- 6" above natural ground.

Wet Well & Valve Vault Slab Surface +1'-6" Above Natural Ground

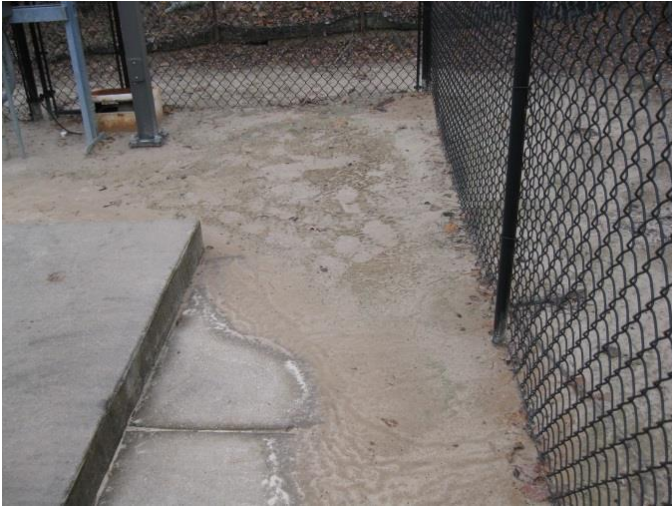
Erosion Silt on Concrete Surface Facing East

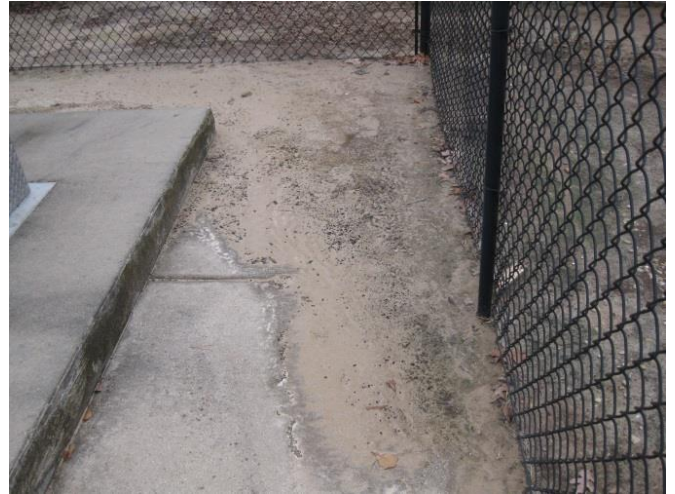
Erosion Silt on Concrete Surface Facing West

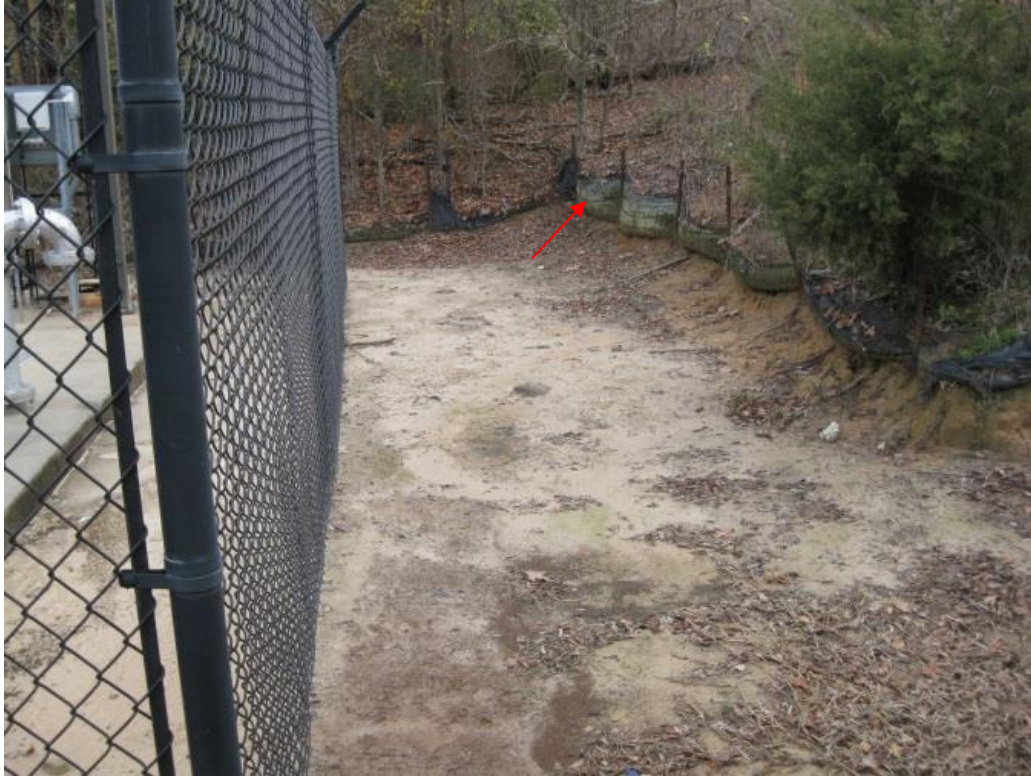
Uphill Slope Behind Lift Station Held Back By Fence.  
Fence in Poor Condition but Not City Property  
to Allow For Repair and Maintenance

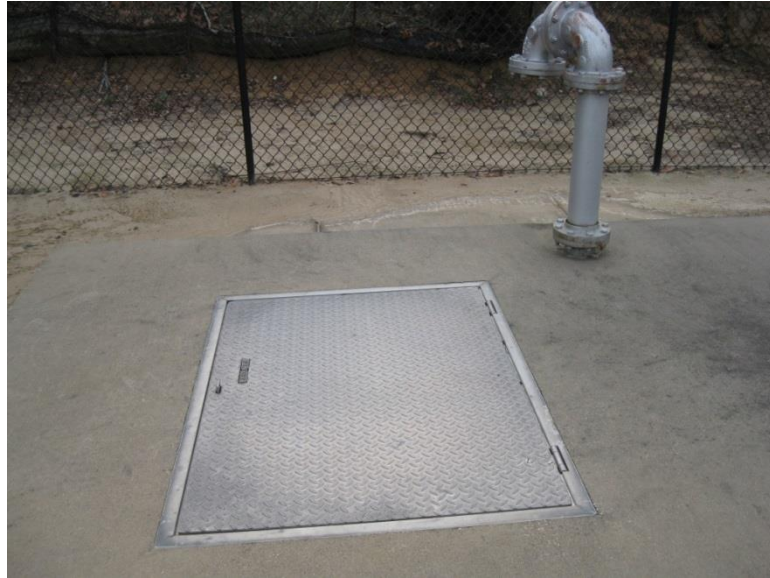
Wet Well Hatch

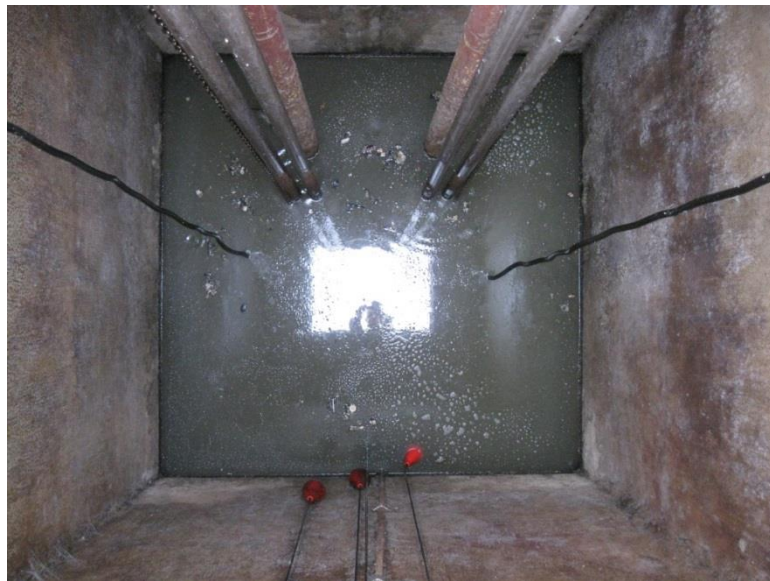
Wet Well Interior

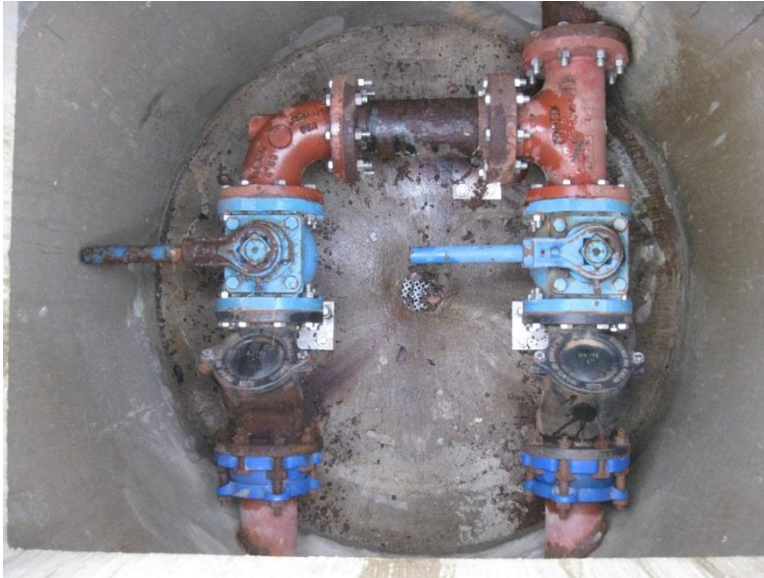
Comments one check valve-good, one has significant corrosion. Compressor for wetwell aeration

Check Valves – Corrosion Observed

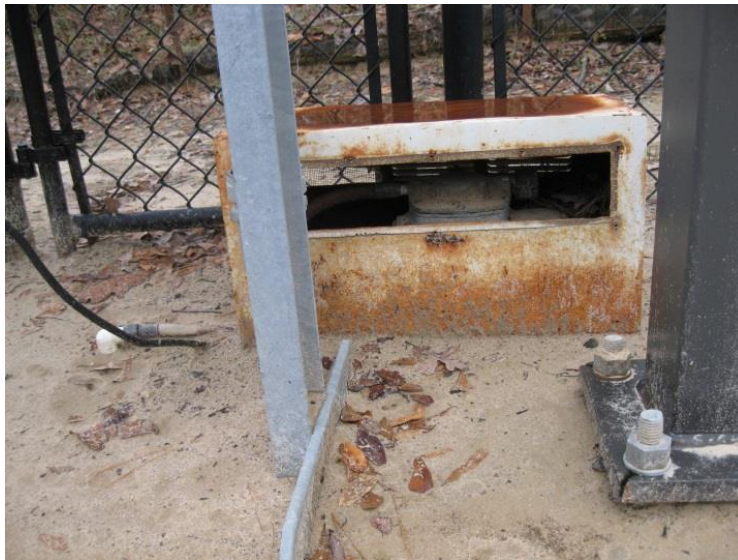
Air Compressor in Cover- Signs of Corrosion

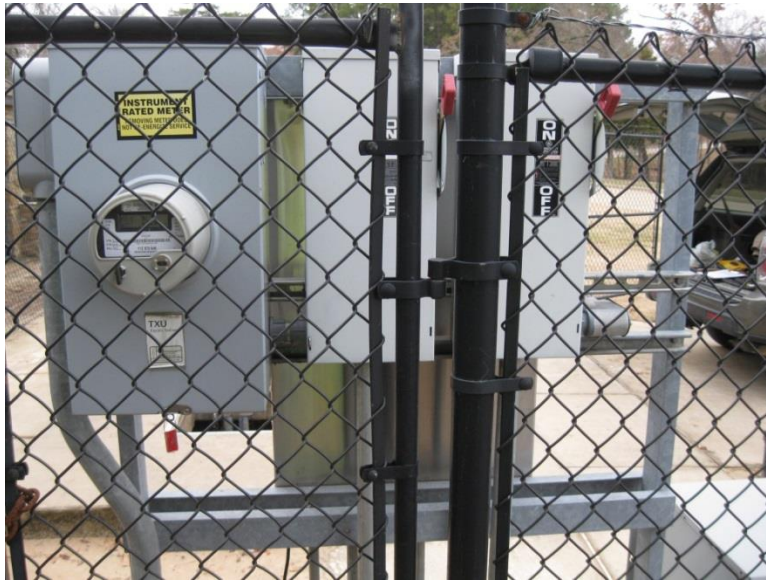
Electrical Panel Facing North

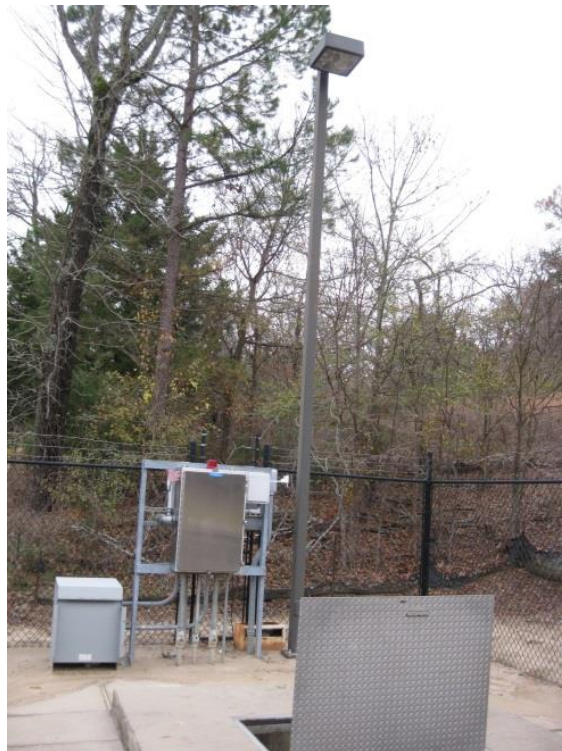
Electrical Panel Mounted on Vertical Frame

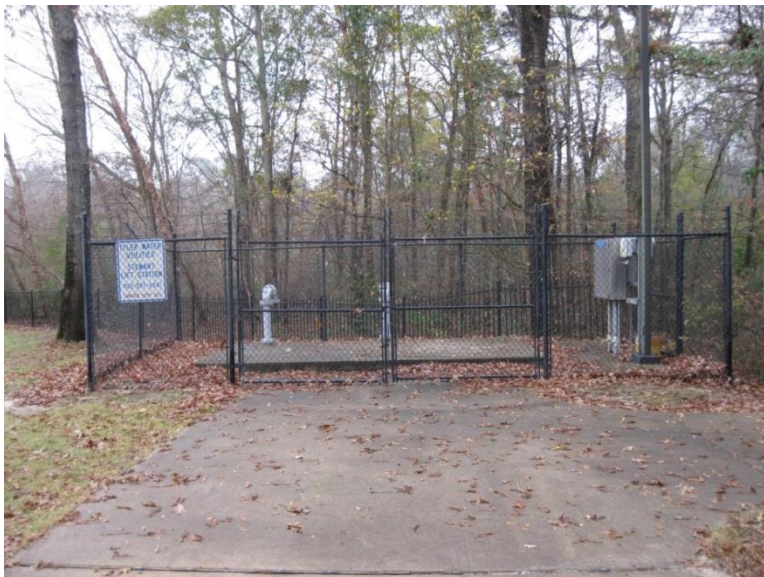
Lift Station Perimeter and Gate

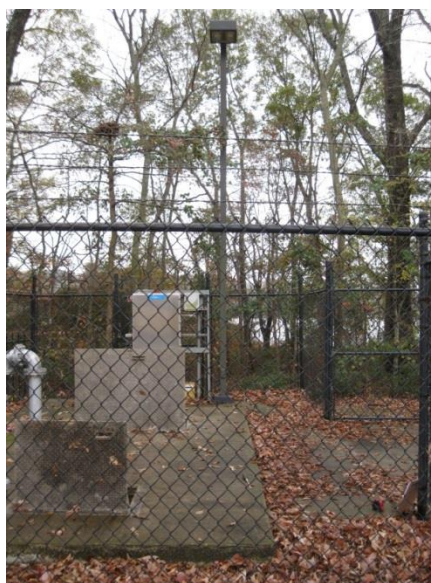
Lift Station Wet Well Slab

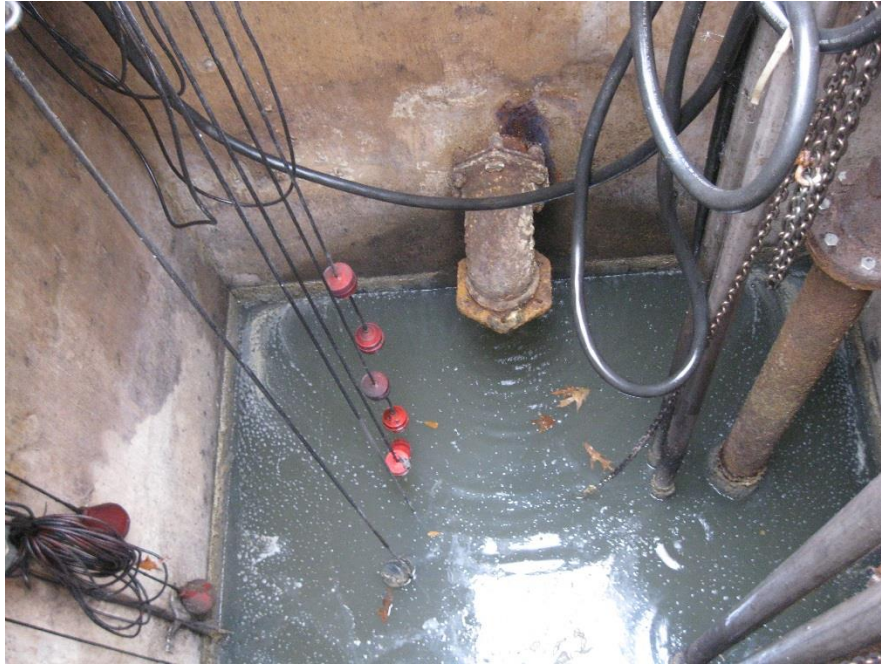
Wet Well Interior

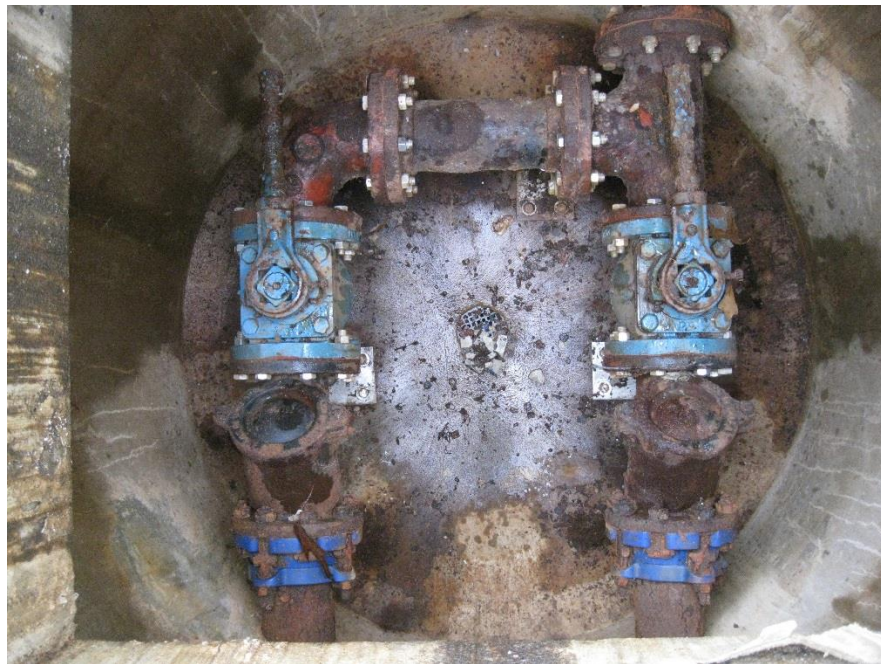
Valve Vault Interior

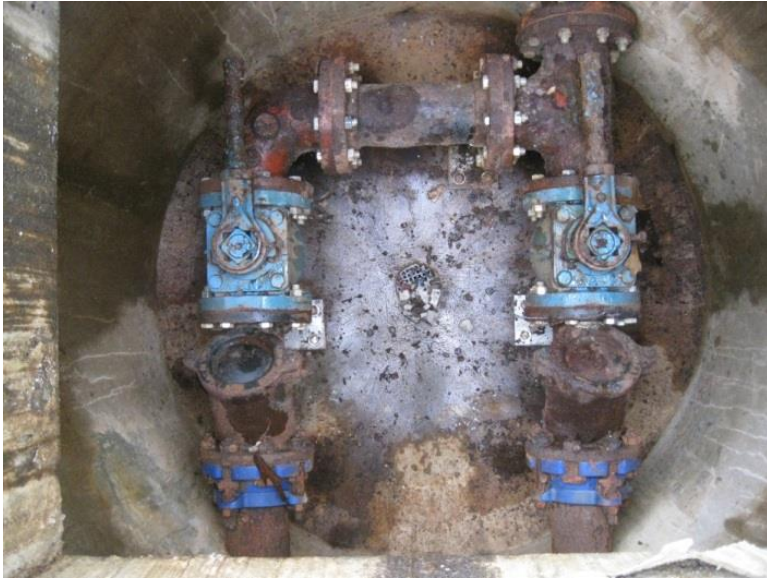
Comments Significant corrosion on all elements. compressor for wet well aeration.

Check Valves With Significant Corrosion

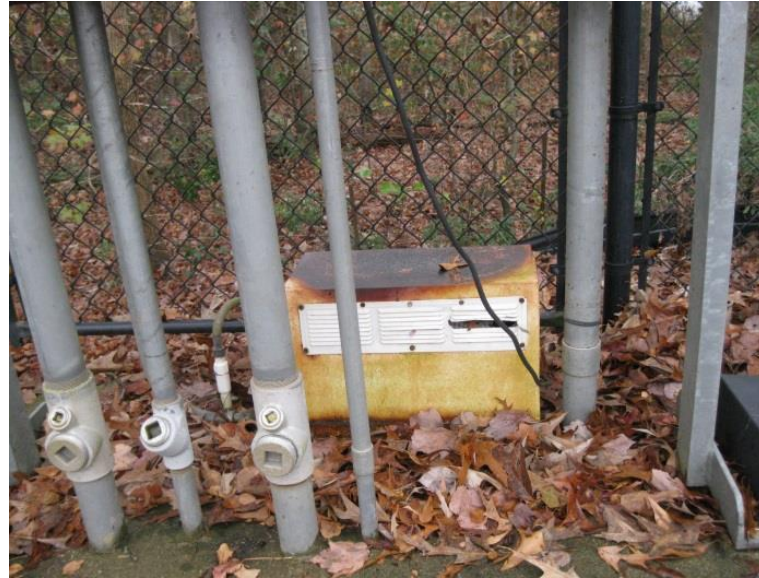
Air Compressor For Wet Well Aeration

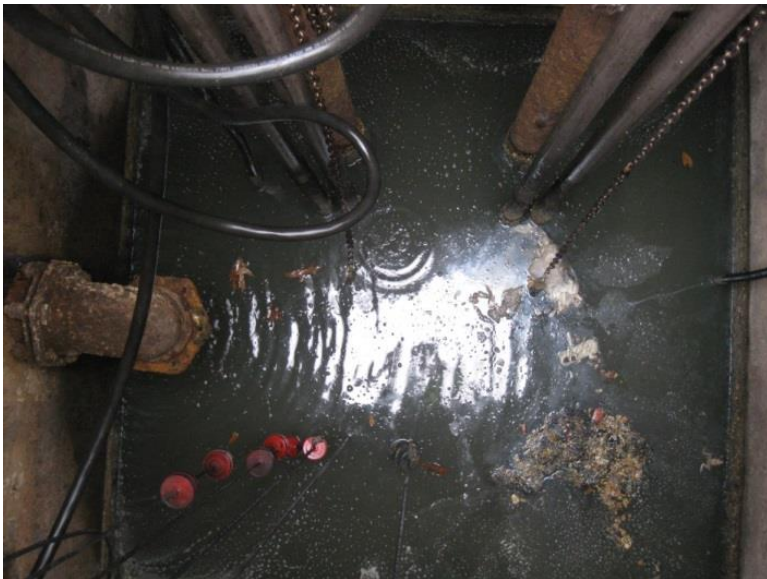
Wet Well Piping Showing Signs of Corrosion

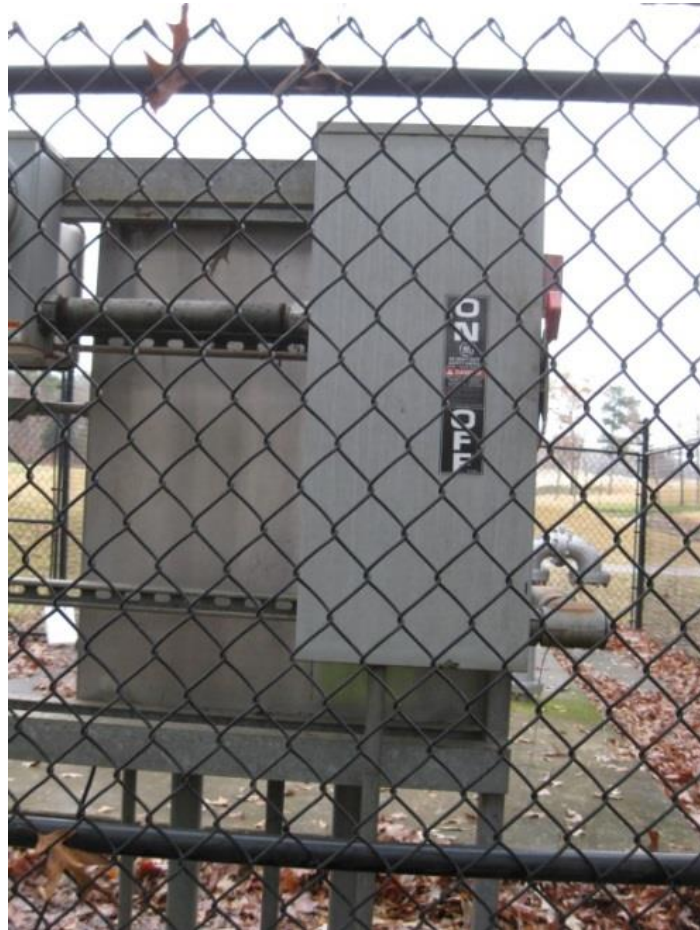
Electrical Panel

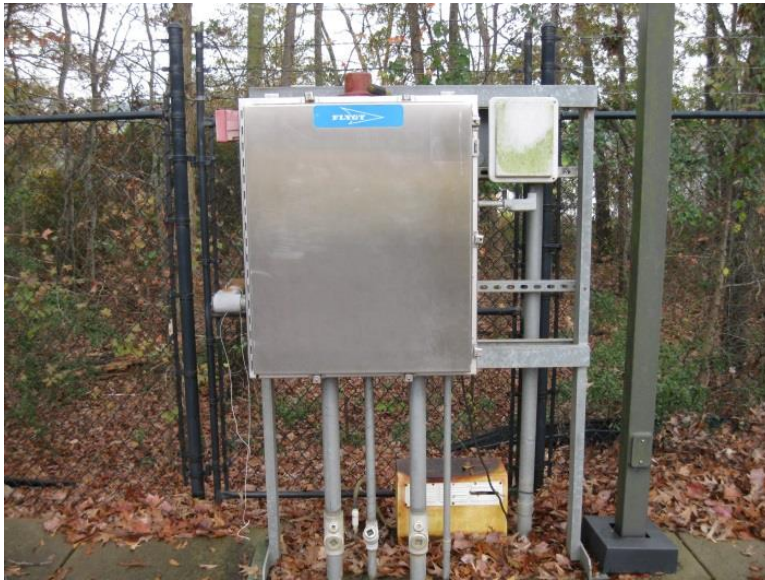
Front of Instrumentation Panel

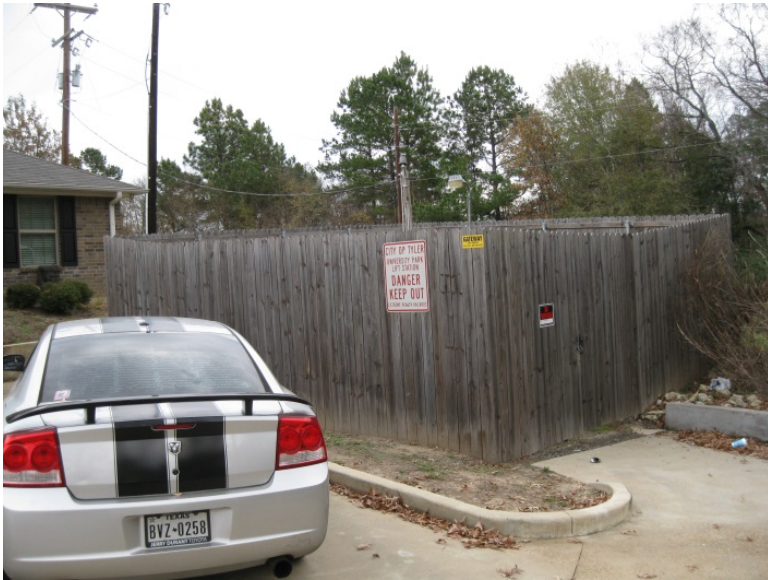
Lift Station Perimeter Facing North

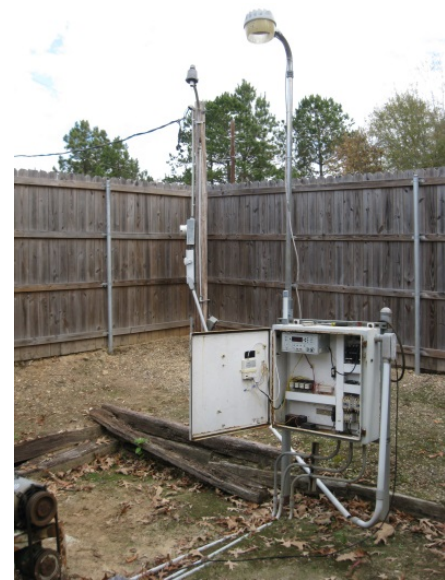
Lift Station Perimeter Facing South.  
Light Bulbs Broken in Both Lights On Site

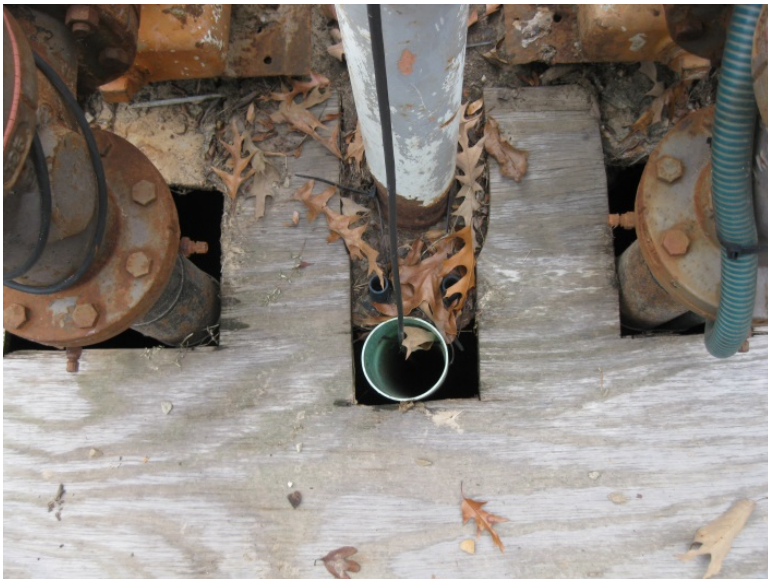
Comments bulbs out on both lights; wet well top in ground low - openings in wet well top allow drainage into wet well - also from drive. Rail road tie retaining wall deteriorated

Wet Well Top Covered With Wooden Board.  
Openings Allow I/I Into Wet Well

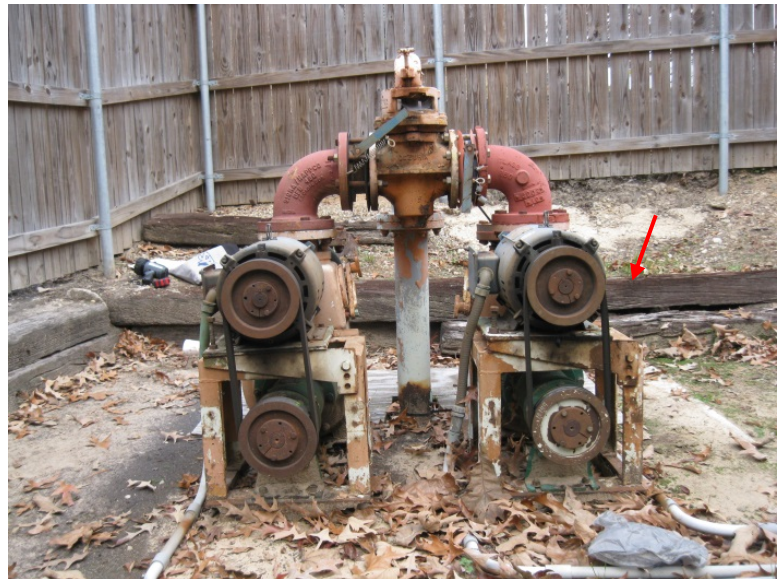
Ground From North Side Sloped Towards Wet Well Slab.  
Railroad Tie Retaining Wall Visible Behind Pumps

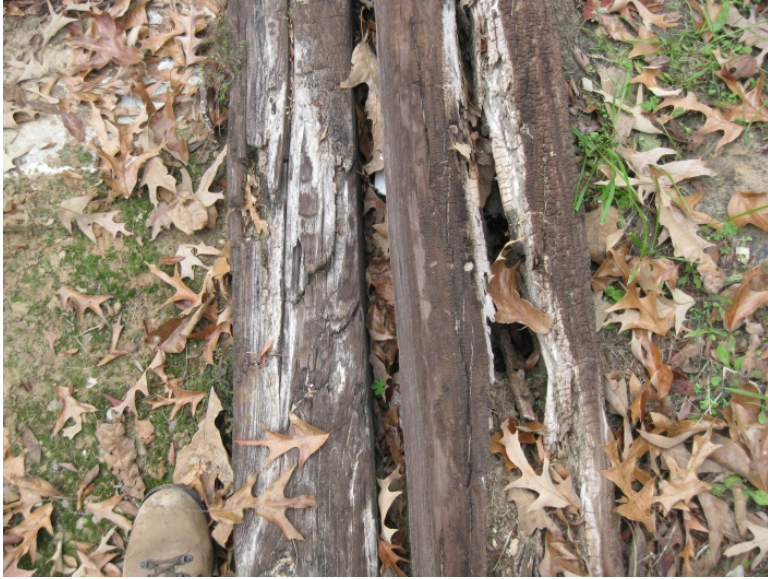
Railroad Tie Retaining Wall Deteriorated (1)

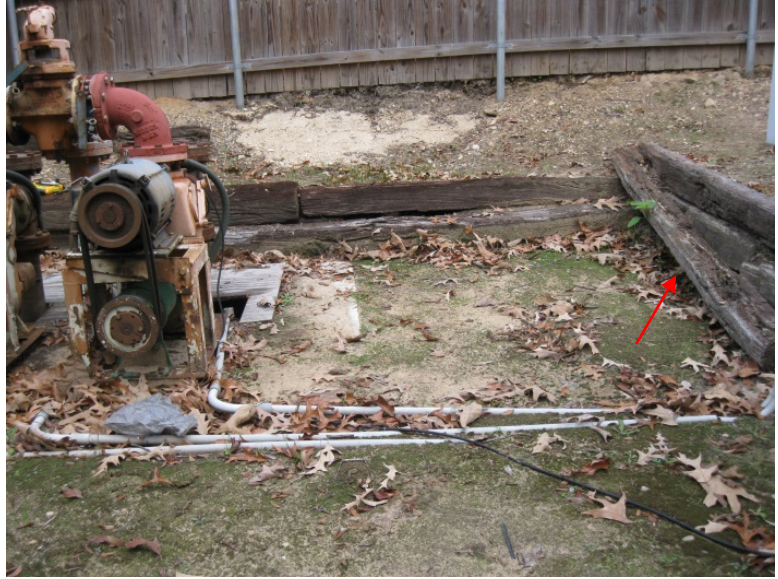
Railroad Tie Retaining Wall Deteriorated (2)

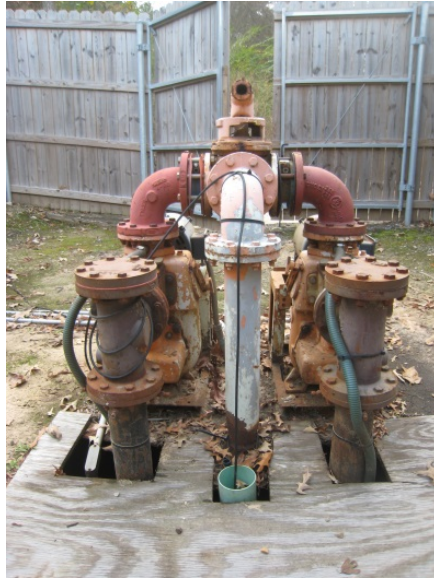
Comments Wet well walls pitted w/ exposed aggregate, steel cover-corrosion, ply wood cover over ~ 2'-6" x 4'-6" opening in metal cover. 1" return line from each pump discharge piping to wet well for aeration

Wet Well Opening Covered With Wood Board. No Wet Well Hatch In Place

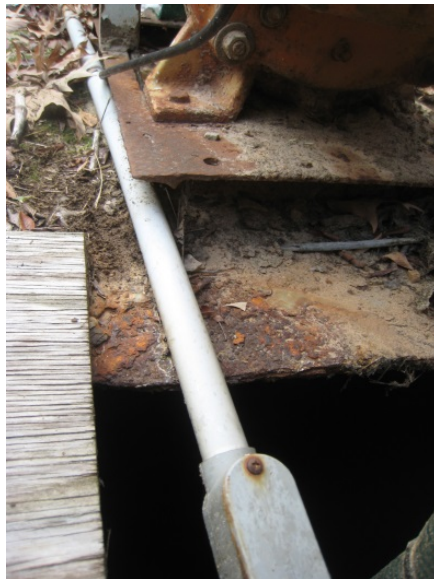
Significant Corrosion on pumps and Frames, Motors have grease accumulation on shaft

Pump Frames Corroded

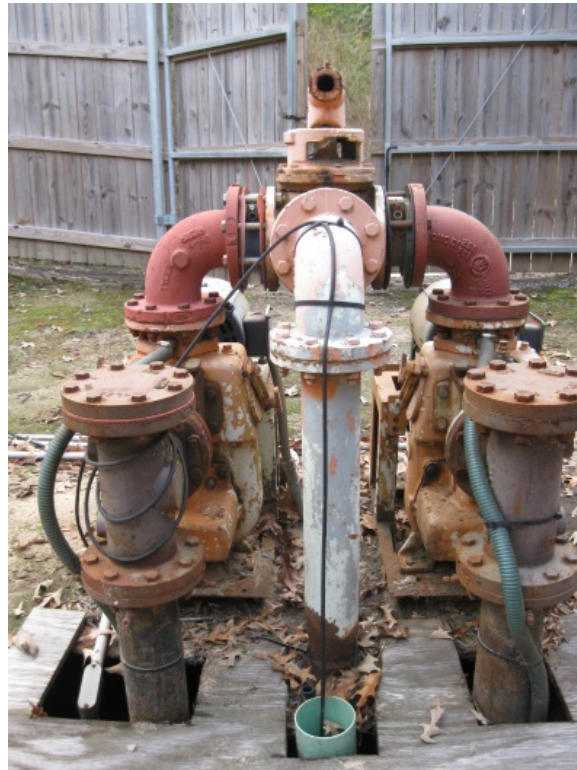
Comments Significant Corrosion on all components.  
check valve does not work on 1 pump, combined discharge pipe  
leaks into wet well during and after pumping

All Components With Significant Corrosion;  
Check Valve on Pump 1 Not Working

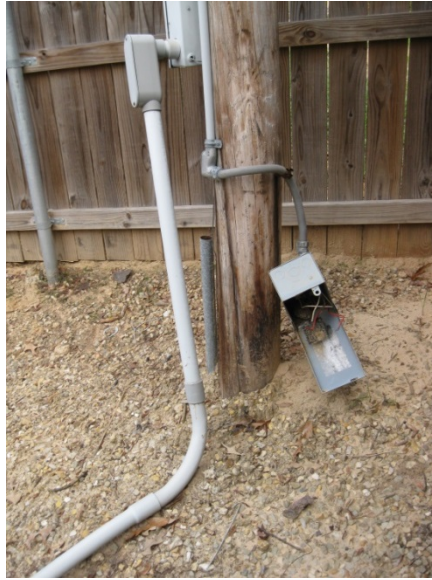
Open Exposed Junction Box at Base of Service Pole

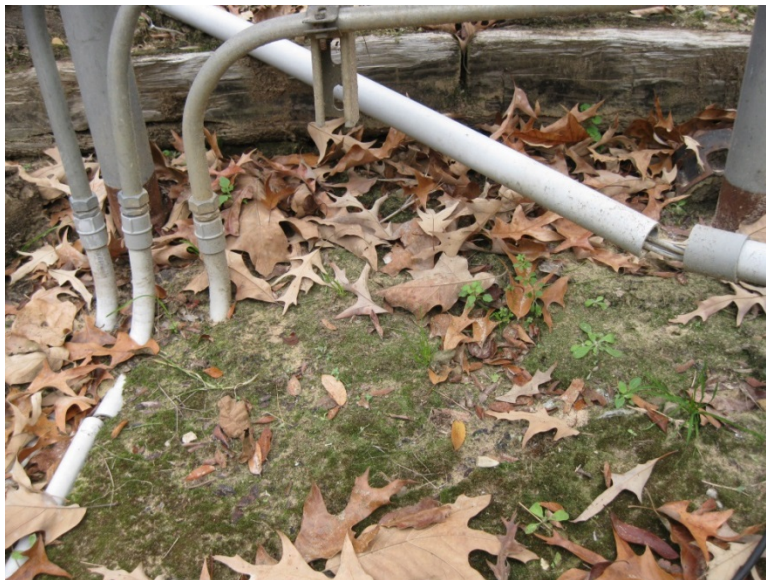
PVC Wire Conduit Not Connected at Fitting

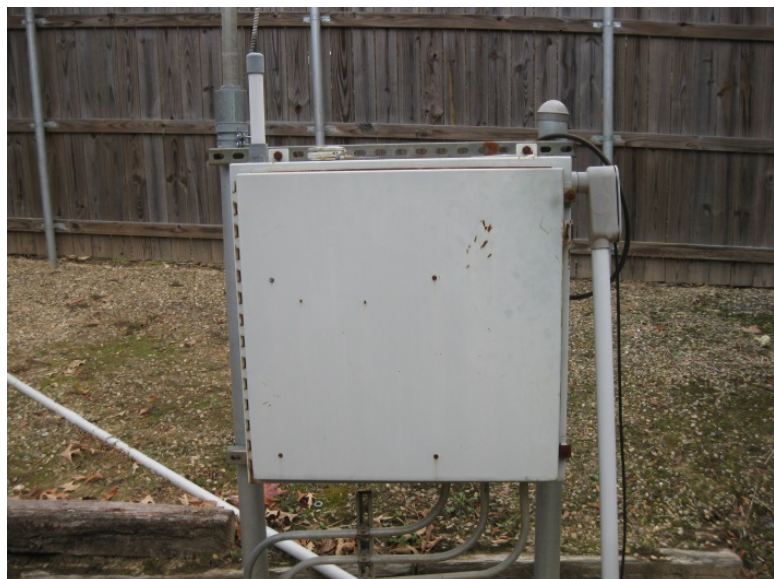
| | | | | Good | Fair | Poor | Critical | N/A |
|---|---|---|---|---|---|---|---|---|
| Comments | | | | Panel has corrosion | | | | |

Instrumentation Panel With Corrosion

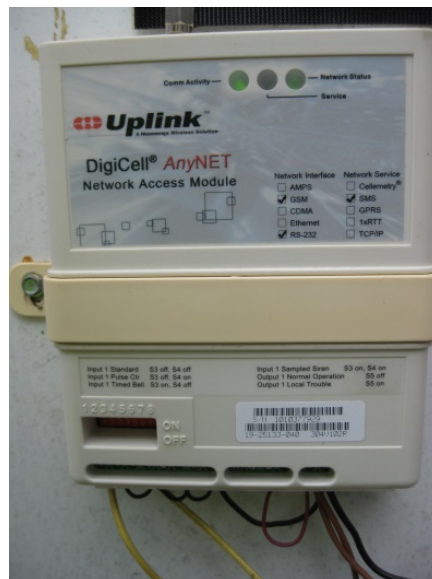
Uplink RTU Inside Instrumentation Panel Door

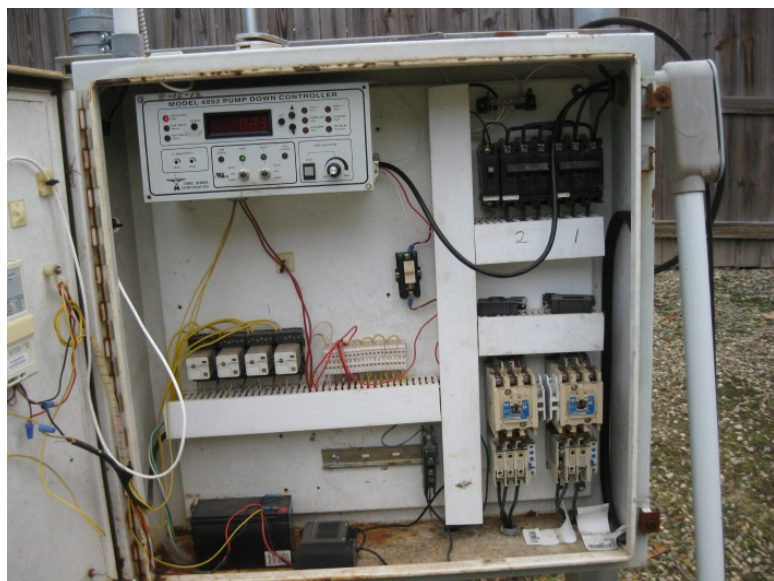
Inside Instrumentation Panel

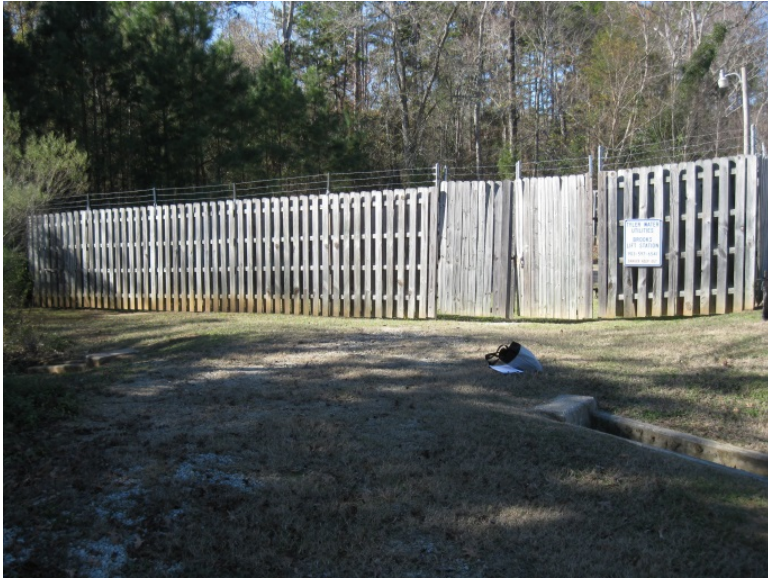
Lift Station Perimeter Facing West

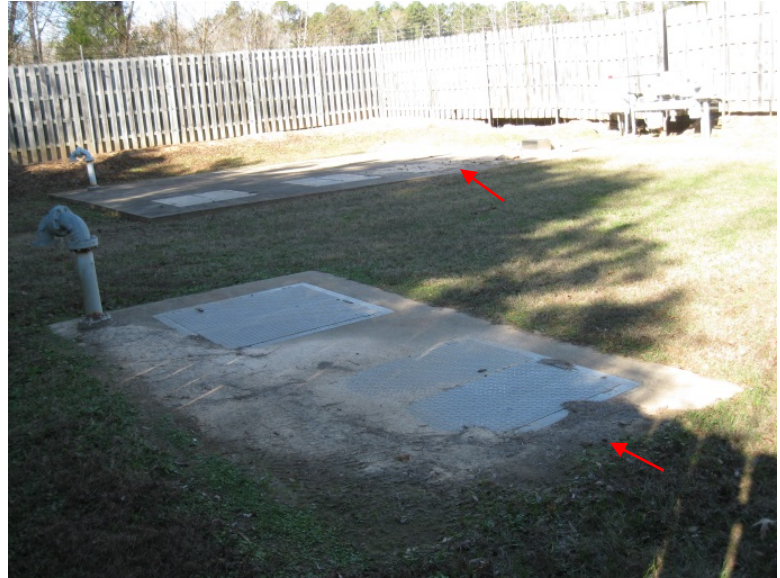
Comments Valve & Wet Well slab flush w/ natural ground.  
Erosion over valve pit slab and wet well  
slab. Some wood fence slats are broken or  
deflected.

Valve Vault and Wet Well Slab Flush With Natural Ground

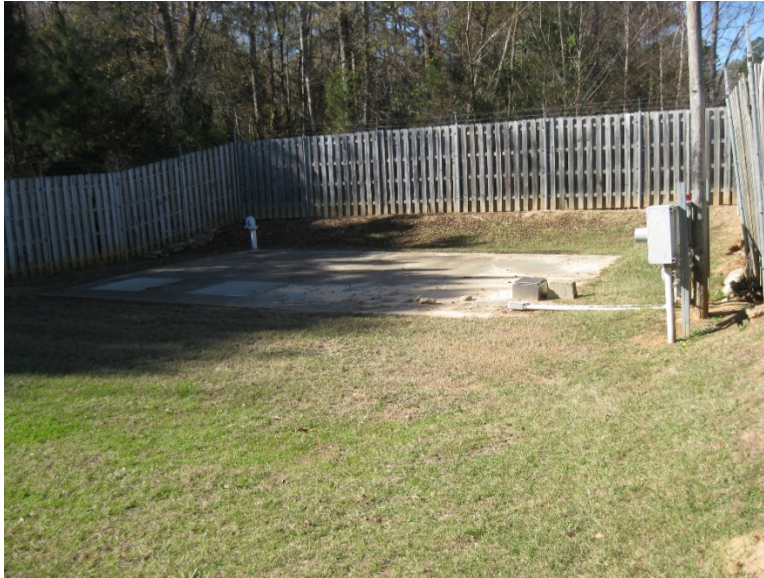
Lift Station Perimeter Facing East

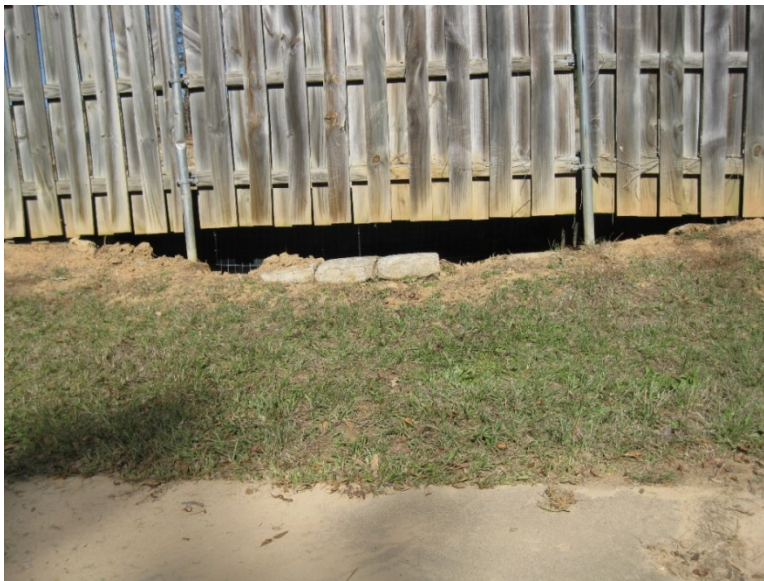
Erosion Around Fencing Facing South

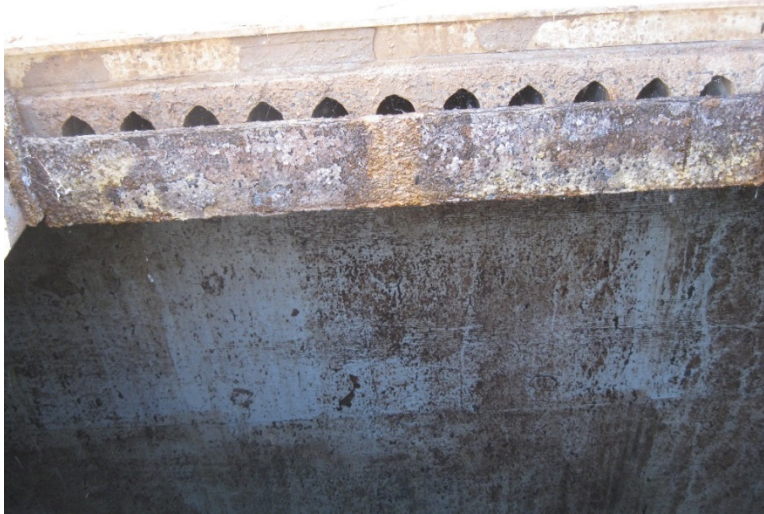
Wet Well Rim Not Coated and Showing Some Corrosion

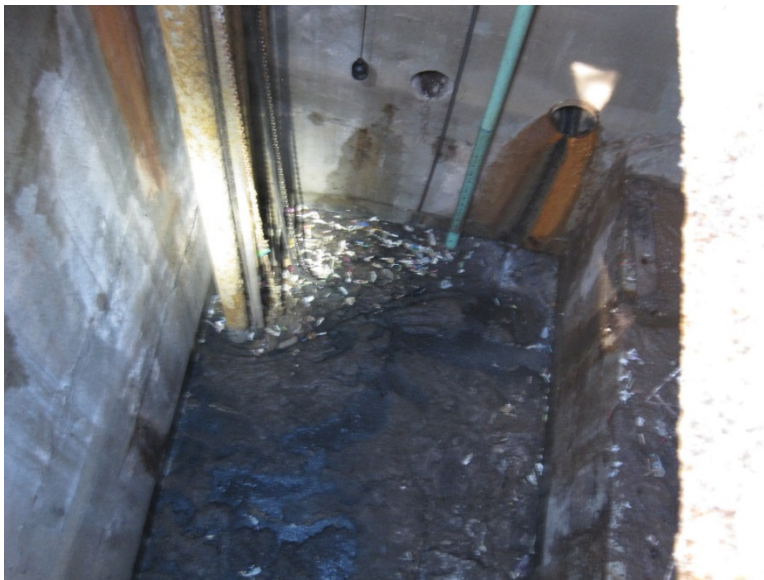
Wet Well Concrete Walls in Good Condition

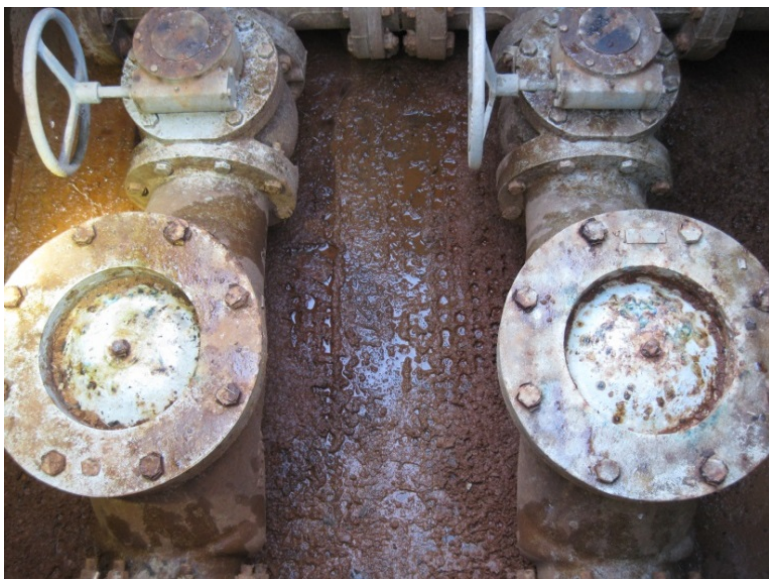
Comments CORROSION ON VALVES AND FITTINGS

Minor Corrosion on Valves in Valve Vault

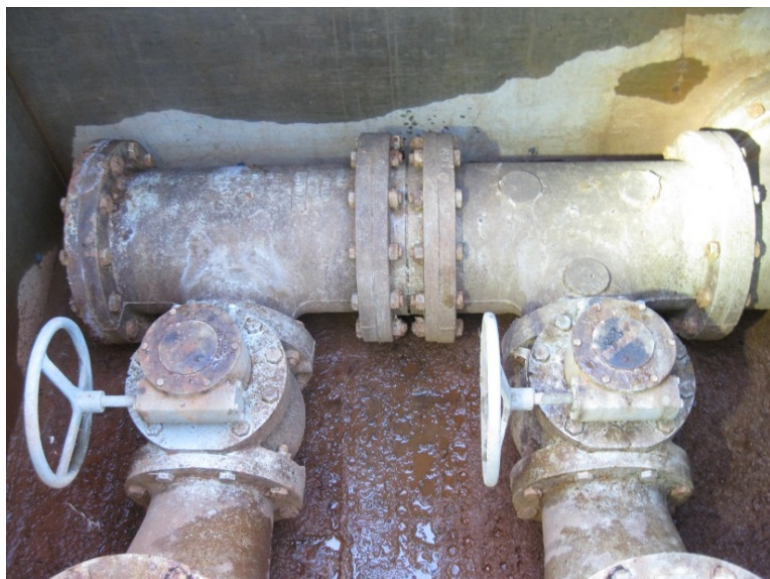
Valve Vault Interior

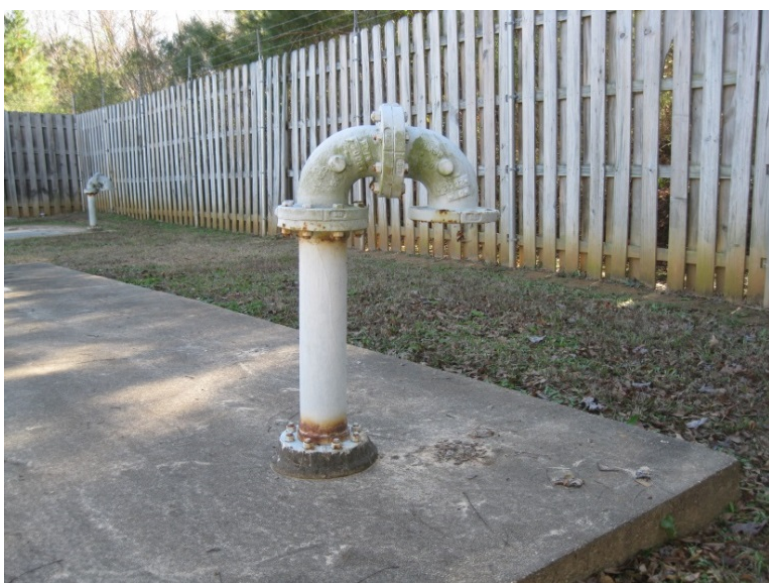
Minor Corrosion on Ventilation Pipe

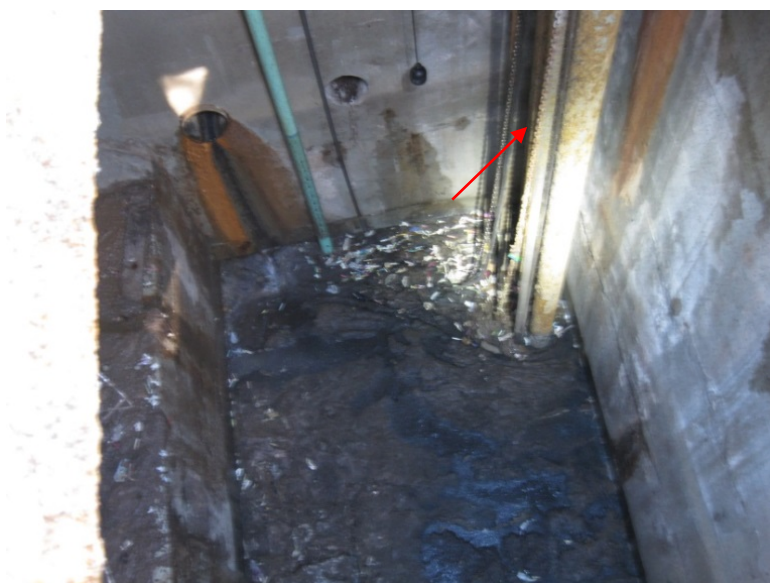
chains have corrosion. Guide Rails and electric conduits - Good

Corrosion on Chains and Rails

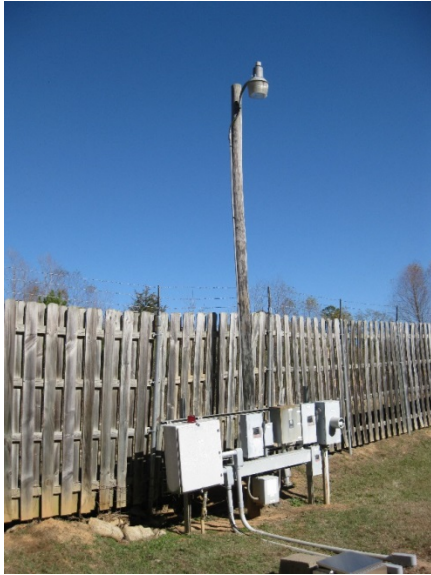
Electrical and Instrumentation Panel Facing South

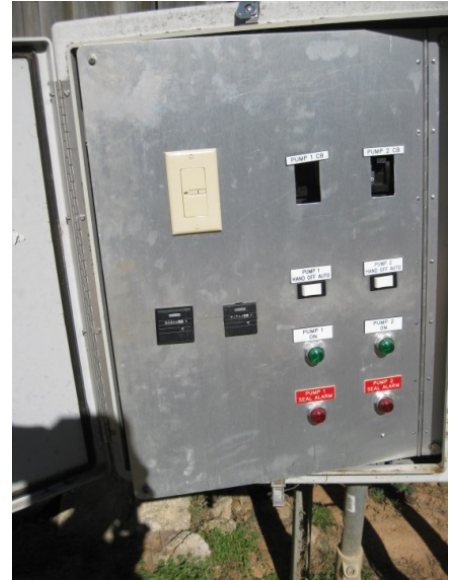
Electric Panel Interior

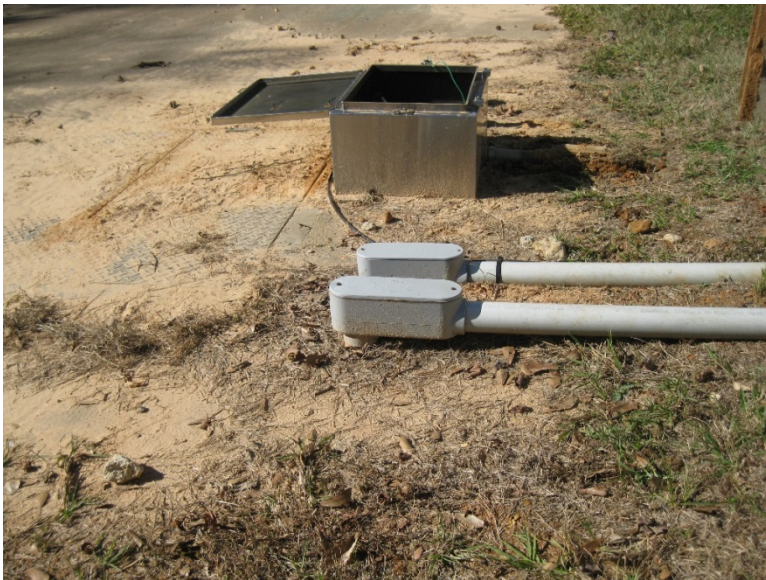
Abandoned Electrical Junction Box on Wet Well Slab

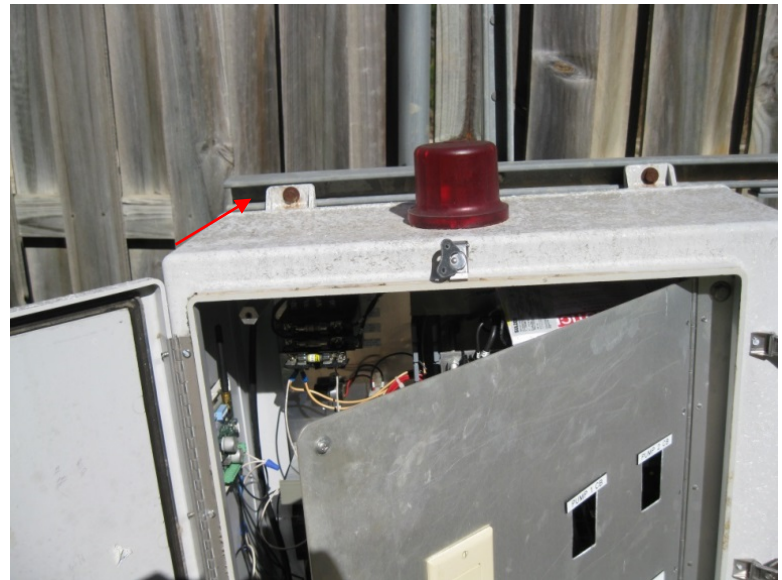
Open EMT on Top of Electric Panel Allows Rainwater to Enter. Alarm Light On Top of Panel Disconnected

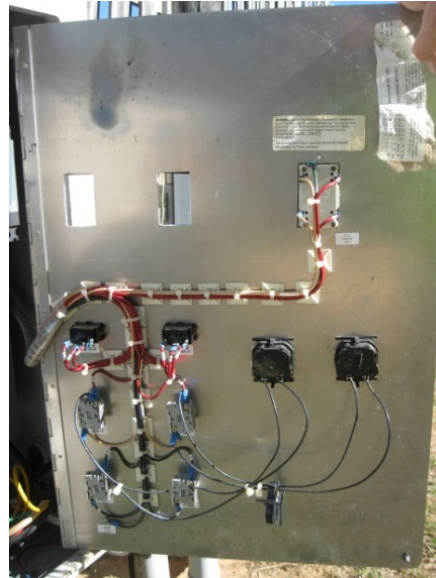
Instrumentation Panel Door

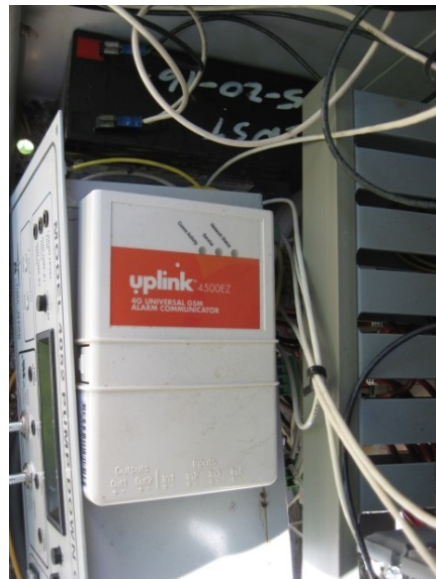
Uplink RTU
