# **Force Main and ARV Condition Assessment Report and Remedial Measures Plan**

**Tyler Water Utilities**

**October 2018**

**Force Main Assessment and Remedial Measures Program Report**  
**October 2018**

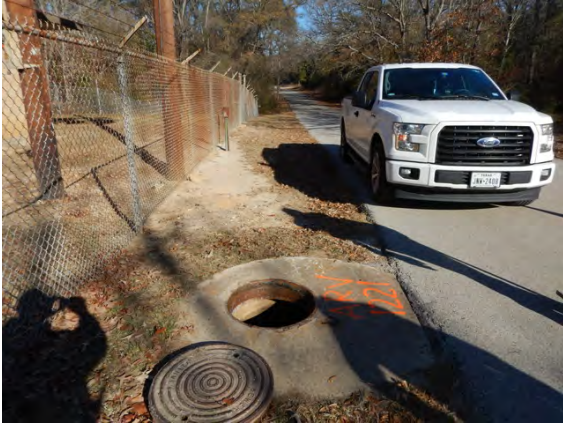
ARV 1221 Bellwood Manhole and Area in Good Condition

| AIR RELEASE VALVES (ARV) | | | | |
|---|---|---|---|---|
| 1 | Bellwood | 1221 | Good Condition | Install Inflow Dish |

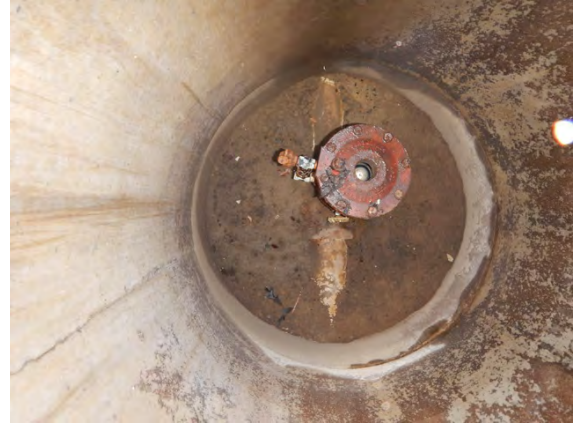
ARV 1221 Bellwood Force Main Visible in Manhole; Air Released While on Site

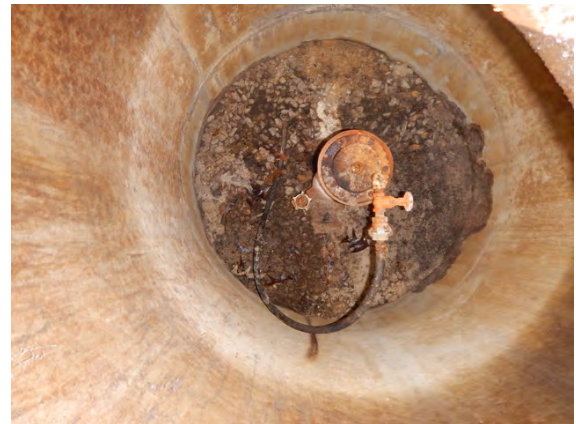
- **Bellwood Force Main:** Two additional ARVs were located in the field which were not a part of the original plans. Both ARVs were located at 10632 CR 1138. ARV 1222 was found to be in poor condition and did not release air when operated.

ARV 1222 Bellwood Top of Force Main Visible in Manhole; (2) Valves Operate With Minor Rust, No Air Released While Operating Valves

| AIR RELEASE VALVES (ARV) | | | | |
|---|---|---|---|---|
| 2 | Bellwood | 1222 | Poor | Replace ARV. Replace MH ring, cover and concrete collar. Install Inflow Dish. |

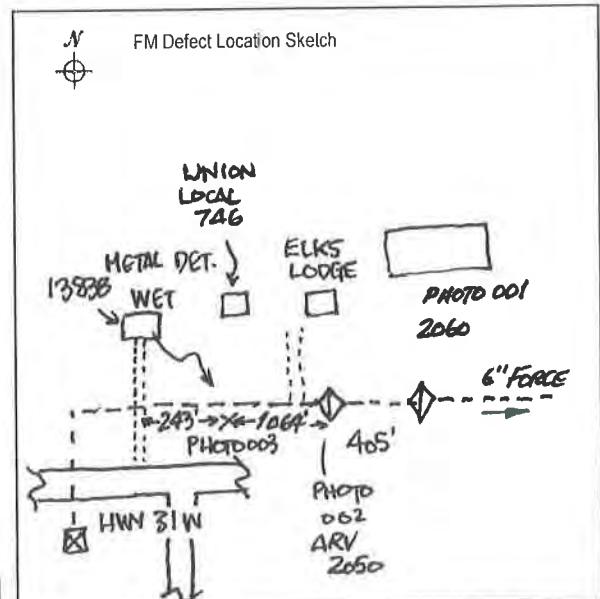
03 OVERLINE

Comments PHOTO 3 WET SPOT 243' E OF CL OF 13838 DRIVEWAY. METAL DETECTED FOR ARV 2040.. WET SPOT AT APPROX. LOCATION.. NO OTHER SURFACE DEFECTS NOTED. LOCATED ARV'S 2050 AND 2060.  
PIC 1 ARV 2060  
PIC 2 ARV 2050  
PIC 3 WET SPOT AT VICINITY OF ARV 2040.. (CNL)  
COULD NOT CONFIRM DISCHARGE LOC.  
PLAN SHOWS @ MH 00491

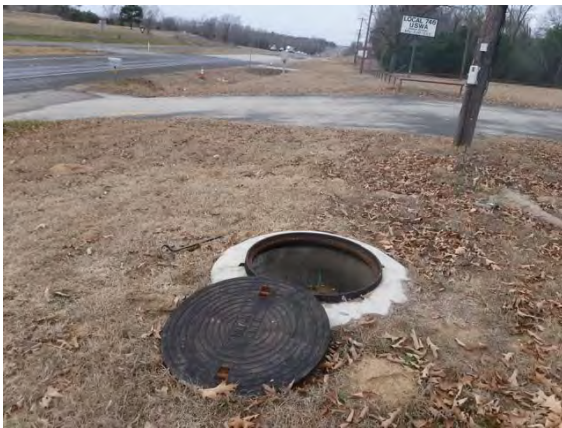
ARV 2050 Highway 31 West Manhole and Area in Good Condition

| AIR RELEASE VALVES (ARV) | | | | |
|---|---|---|---|---|
| 5 | Highway 31 West | 2050 | Fair Condition | Install Inflow Dish on ARV manhole |

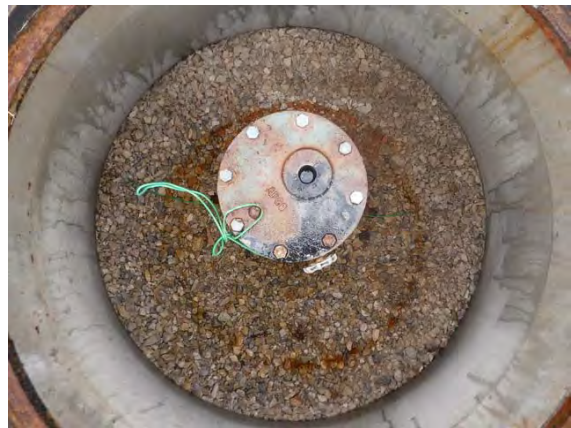
ARV 2050 Highway 31 West Air Release Valve in Good Condition, Valve Turns but No Air Was Released; Force Main not Visible in Manhole

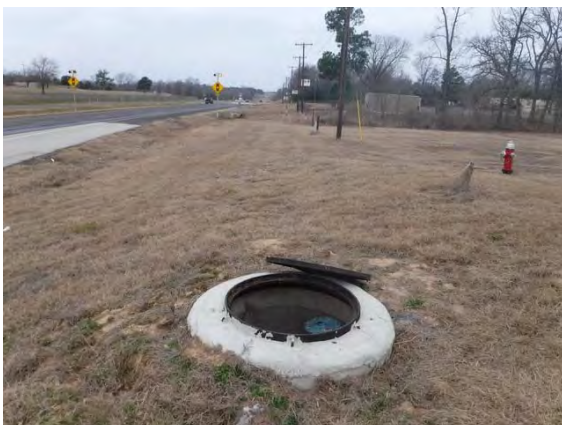
ARV 2060 Highway 31 West Area and Manhole in Good Condition

| AIR RELEASE VALVES (ARV) | | | | |
|---|---|---|---|---|
| 6 | Highway 31 West | 2060 | Fair Condition | Install Inflow Dish on ARV manhole |

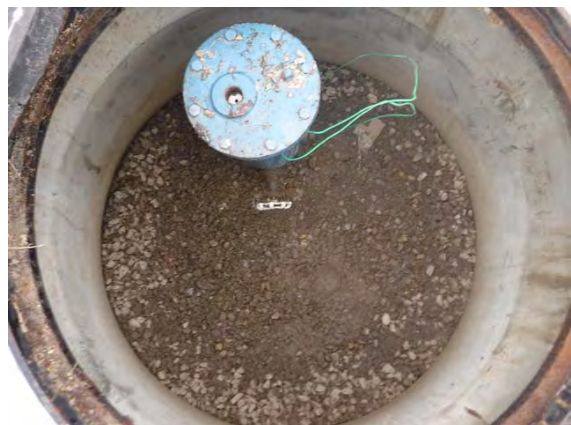
ARV 2060 Highways 31 West Force Main not Visible in Manhole; ARV Turns Properly but No Air Was Released

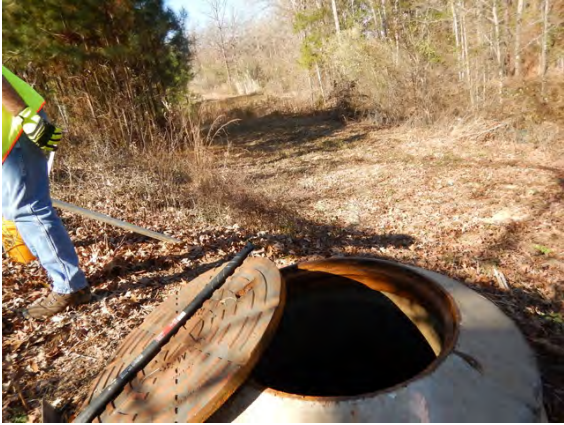
ARV 1350 Nottingham Area and Manhole in Good Condition

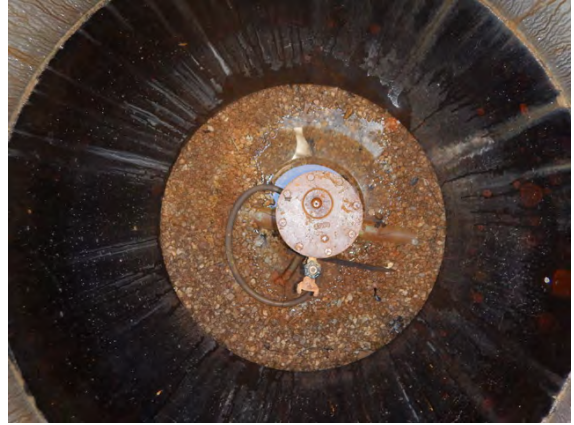
ARV 1350 Nottingham Force Main Crown Visible in Manhole; (2) Valves on ARV

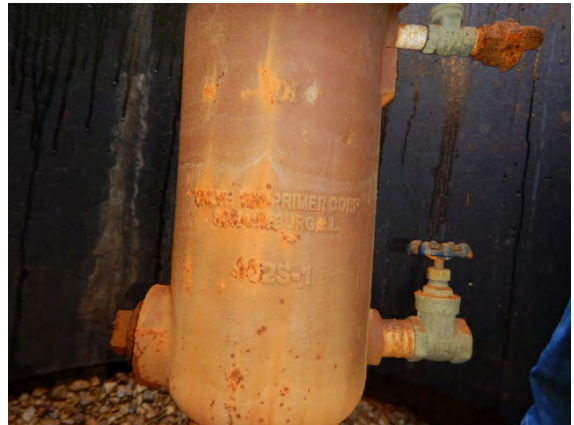
- **Nottingham Lane Force Main:** A section of the force main is exposed at a creek crossing approximately 100 feet west of CR 274 due to surface erosion. No surface defects were noted during the assessment. Minor corrosion was observed on ARV 1350 and the valve did not operate freely.

ARV 1350 Nottingham ARV With (2) Valves That Did Not Turn With Minor Rust  
Nottingham Erosion

| AIR RELEASE VALVES (ARV) | | | | |
|---|---|---|---|---|
| 8 | Nottingham Lane | 1350 | Poor | Replace ARV. Install Inflow Dish on ARV manhole. |

- **Nottingham Lane Force Main:** A section of the force main is exposed at a creek crossing approximately 100 feet west of CR 274 due to surface erosion. While no surface defects were noted, in order to avoid the potential for future structural damage to the force main, it is recommended that the site be addressed to protect the force main from future erosion. It is also recommended to encase the 4-inch PVC pipe in a casing to prevent any structural damage to the pipe.

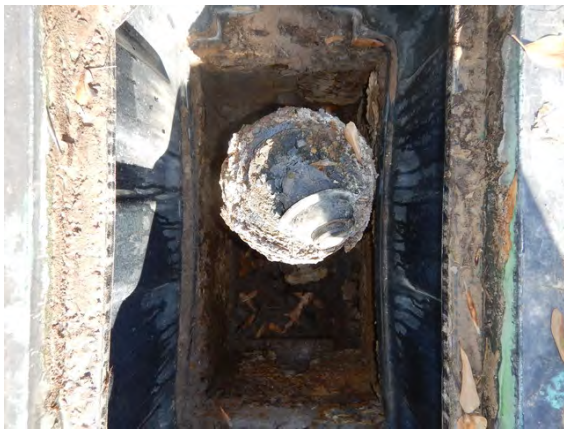
ARV 1260 Pilot Force Main Not Visible in Manhole; (1)  
Valve Not Operable

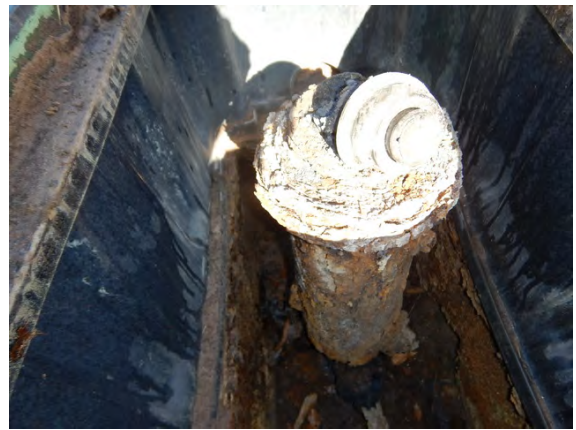
- **Pilot Truck Force Main:** The force main showed no visible defects. Two (2) new ARVs were located at approximately 1220 feet (ARV 1291) and 6368 feet (ARV 1271A) south of the Pilot Truck lift station. ARV 1260 was also located and found to be in critical condition due to corrosion.

ARV 1260 Pilot ARV With Moderate to Severe  
Corrosion on Bolt and Body

| AIR RELEASE VALVES (ARV) | | | | |
|---|---|---|---|---|
| 10 | Pilot Truck | 1260 | Critical | Replace ARV and ARV Vault |

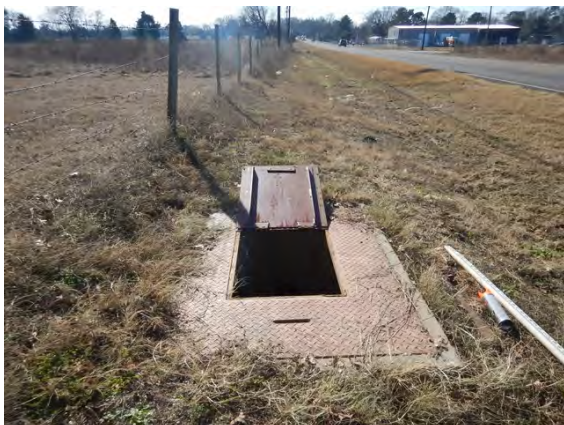
ARV 1271 Pilot Area and Vault in Good Condition

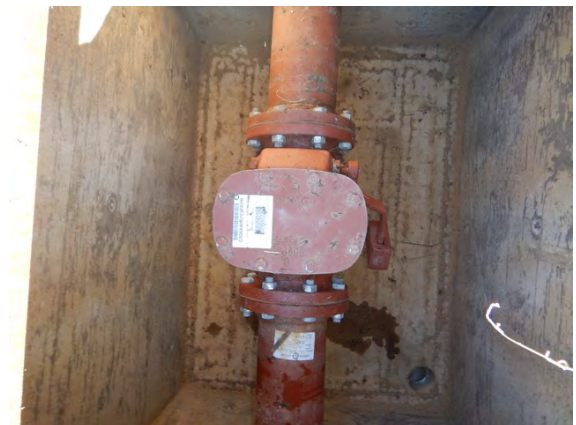
ARV 1271 Pilot Check Valve in Good Condition

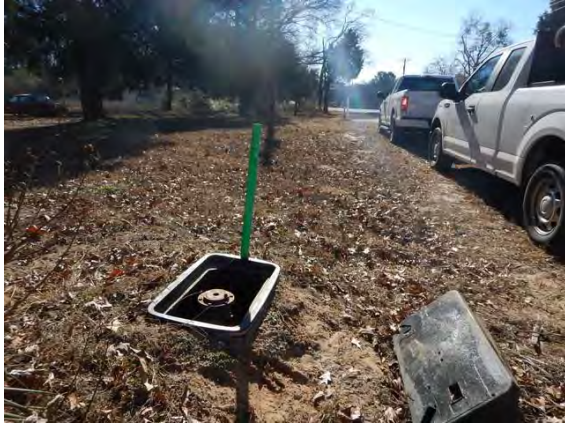
ARV 1291 Pilot Area and Vault in Good Condition

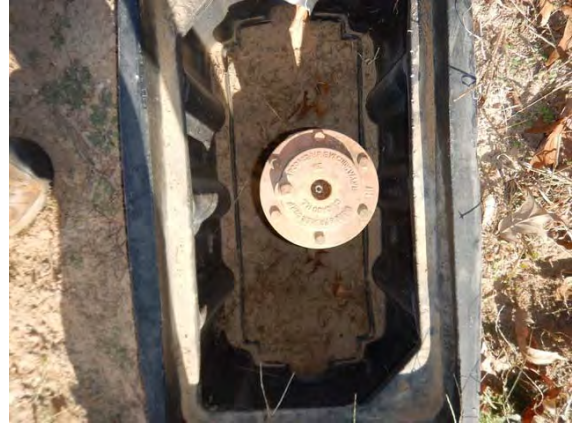
ARV 1291 Pilot Force Main Not Visible in Vault; ARV Operated While on Site, Valve Locations Capped

| AIR RELEASE VALVES (ARV) | | | | |
|---|---|---|---|---|
| 11 | Pilot Truck | 1291 | Poor | Replace ARV and ARV Vault |

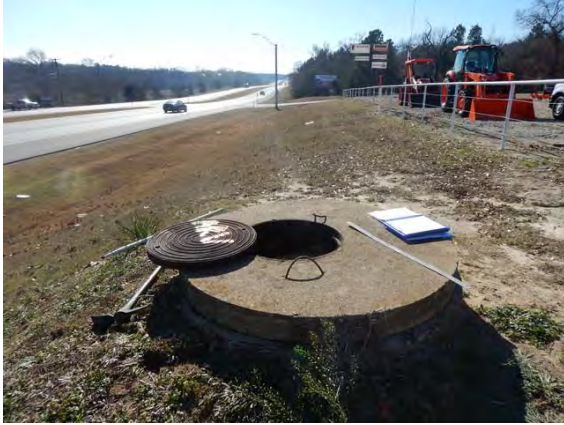
ARV 1310 Rustic Area and Manhole in Good Condition

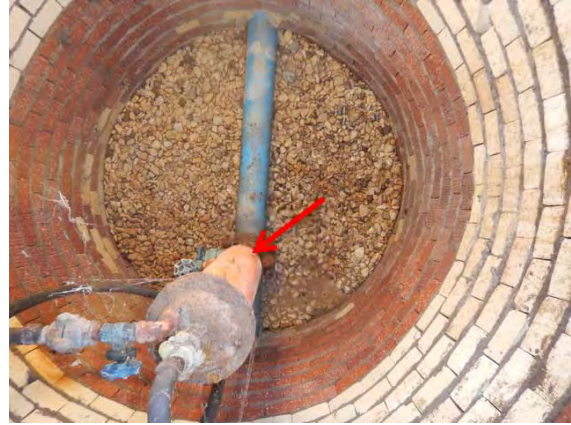
- **Rustic Park Force Main:** ARV 1310 was found to be in poor condition and could not be operated. No defects were noted along the length of the force main.

ARV 1310 Rustic Force Main Line Visible in Manhole;  
Moderate Corrosion on ARV Pipe Strap with Minor  
Rust on (3) Valves

| AIR RELEASE VALVES (ARV) | | | | |
|---|---|---|---|---|
| 14 | Rustic Park | 1310 | Poor | Replace ARV. Install Inflow Dish on ARV manhole. |

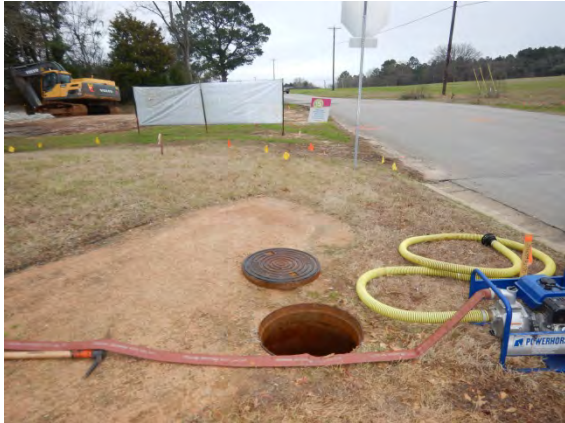
ARV 1300 Crossings Manhole and Area in Good Condition, Minor Corrosion on Manhole

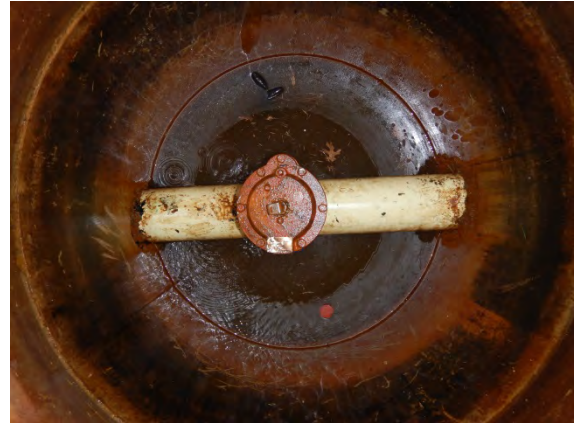
- **Crossing Force Main:** ARV 1300 was located and it was observed that the ARV vault was full of water. The ARV did not release air when operated.
- **Faulkner Force Main:** The construction plans for the force main indicate a 2-inch PVC force main. However, at the discharge manhole, it was observed that the force main was a 4-inch cast iron/ ductile iron pipe.

ARV 1300 Crossings Manhole Surcharged

| AIR RELEASE VALVES (ARV) | | | | |
|---|---|---|---|---|
| 17 | Crossing | 1300 | Poor | Replace ARV and address surcharged vault. Replace manhole ring and cover. |

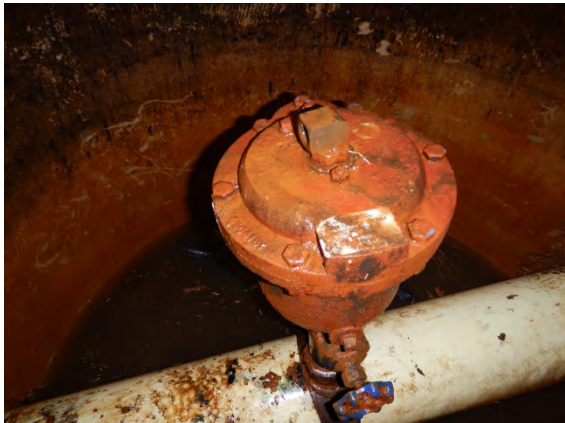
ARV 1300 Crossings Air Release Valve in Fair Condition

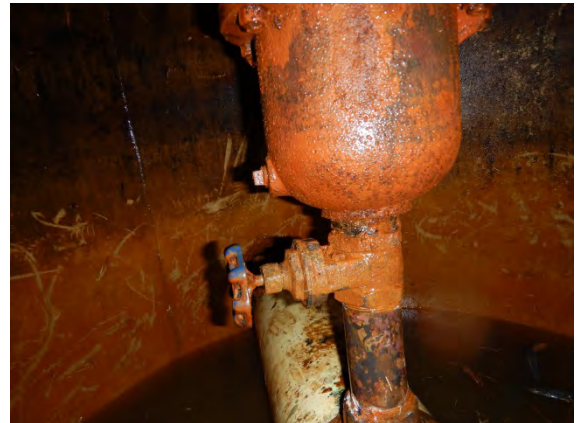
ARV 1300 Crossings Valve in Good Condition

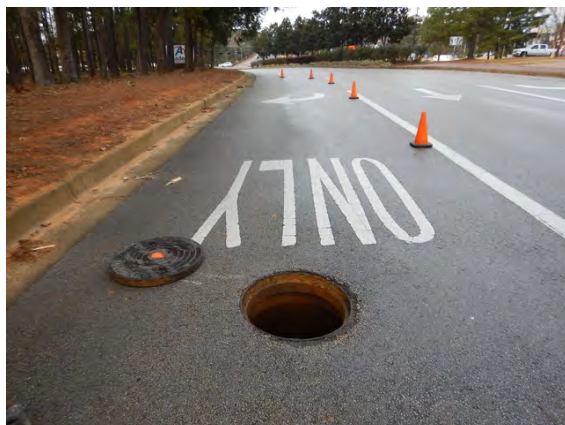
ARV 1300 Crossing Manhole Ring and Cover in Good Condition

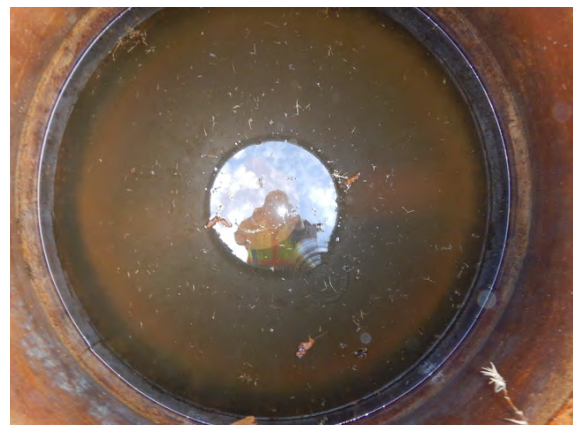
ARV 1300 Crossing Manhole Surcharged

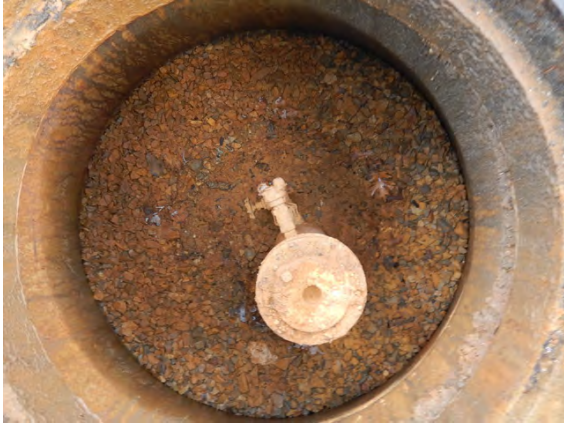
ARV 2020 East Grande Air Release Valve in Good Condition; Force Main not Visible

| AIR RELEASE VALVES (ARV) | | | | |
|---|---|---|---|---|
| 18 | East Grande | 2020 | Good Condition | Install Inflow Dish on ARV manhole |

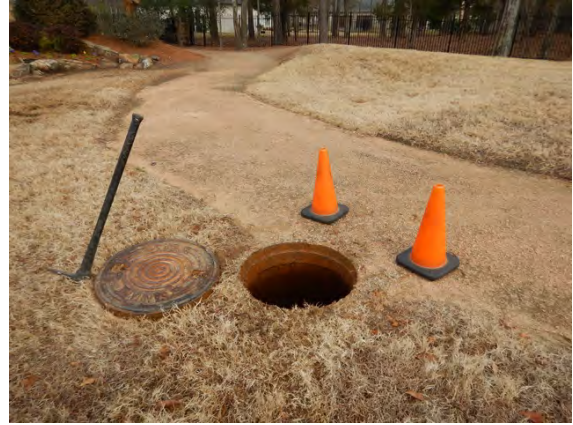
ARV 2020 East Grande Area in Good Condition

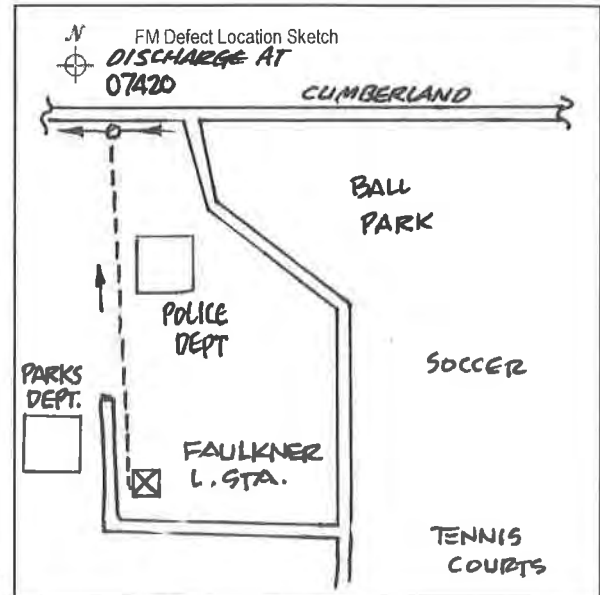
02 DISCHARGE LOC.

Comments WALKED FORCE LINE...  
NO ARV'S LOCATED... NONE SHOWN  
ON PLANS.  
NO DEFECTS NOTED ALONG FORCE LINE.  
CONFIRMED DISCHARGE LOCATION  
AT MH 07420...  
PIPE AT DISCHARGE IS 4" CAST/DUCTILE  
BUT PLANS SHOW 2" PVC FORCE LINE.

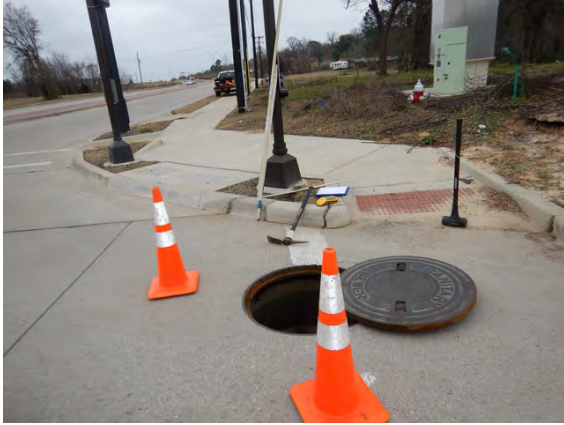
ARV 1330 Oak Creek Area and Manhole in Good Condition

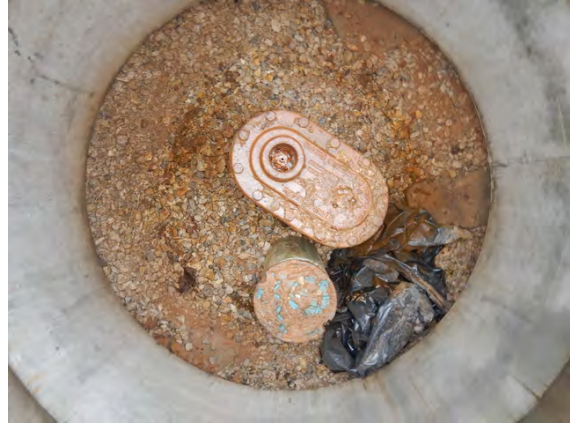
- **Oak Creek Force Main:** A new ARV was located at the crossing of Cumberland and Old Jackville Highway. However, no valves were observed on the ARV.

ARV 1330 Oak Creek Force Main Not Visible in Manhole; No Valves on ARV

| AIR RELEASE VALVES (ARV) | | | | |
|---|---|---|---|---|
| 21 | Oak Creek | 1330A | Good Condition | Install Inflow Dish on ARV manhole |

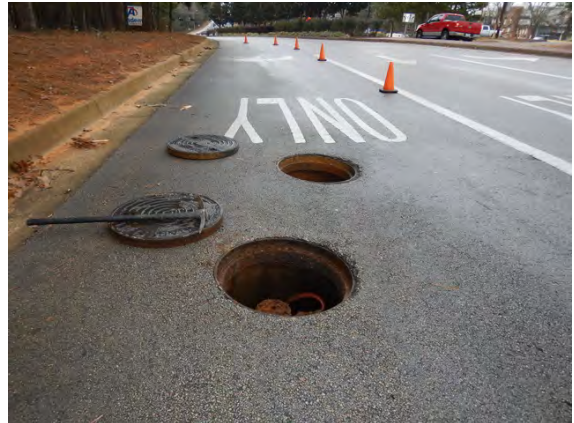
ARV 1230 Shackleford Manhole and Area in Good Condition

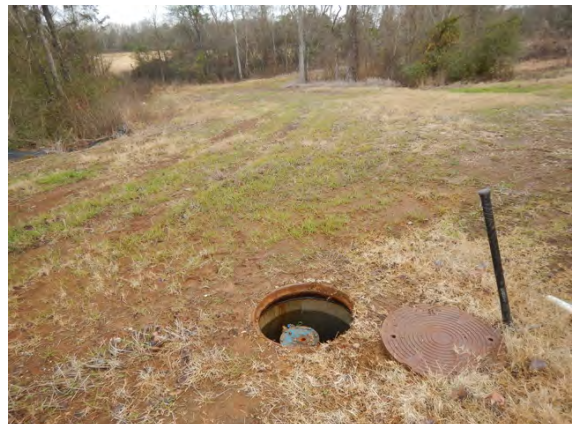
ARV 1231 Shackleford Manhole and Area in Good Condition
