## SHORELINE LIFT STATION

# Tyler Water Utilities - Lift Station Assessment Form

Lift Station Name SHORELINE Type Submersible  
 Location/Address 4588 Cascade Shoreline Drive  
 Lift Station Asset ID \_\_\_\_\_ Number of Pumps 2  
 Firm Capacity in GPM (all pumps operating) \_\_\_\_\_  
 Firm Capacity in GPM (largest pump out of service) \_\_\_\_\_  
 Inspector Don White Date Dec 17, 2017  
 City Works Work Order \_\_\_\_\_

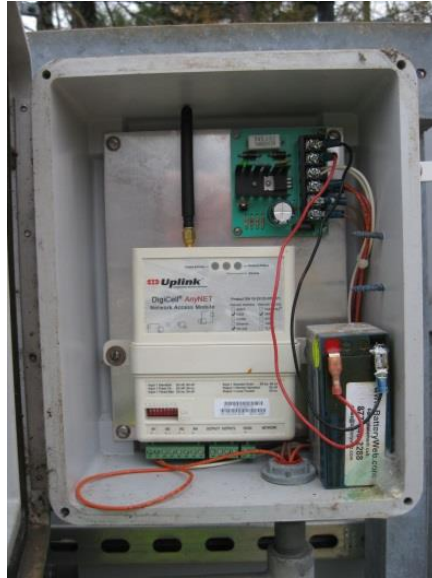
Uplink RTU Inside Instrumentation Panel

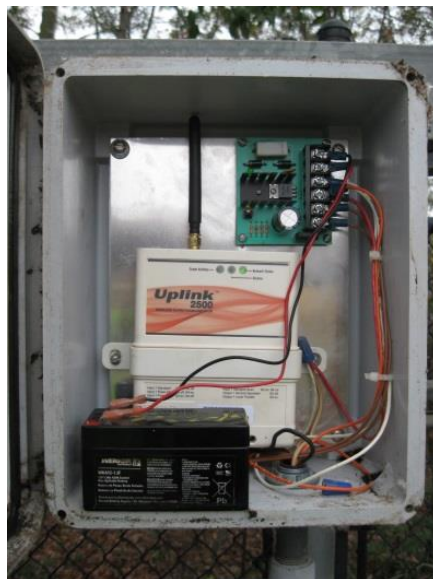
Uplink RTU Inside Instrumentation Panel

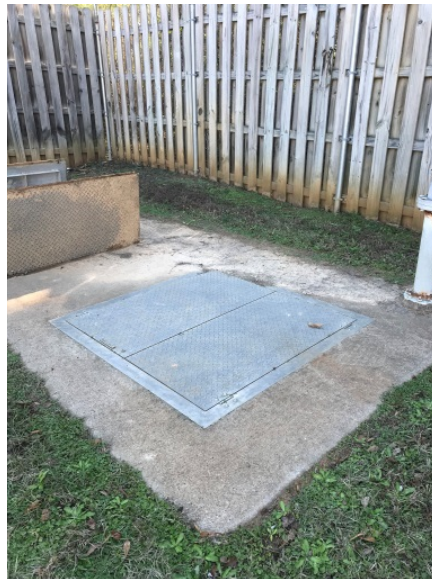
Comments Valve & Wet Well slab flush w/ natural ground.  
Erosion over valve pit slab and wet well  
slab. Some wood fence slats are broken or  
deflected.

Valve Vault Slab Flush With Natural Ground  
with Signs of Erosion Around the Slab
