# **Force Main and ARV Condition Assessment Report and Remedial Measures Plan**

**Tyler Water Utilities**

**October 2018**

**Force Main Assessment and Remedial Measures Program Report**  
**October 2018**

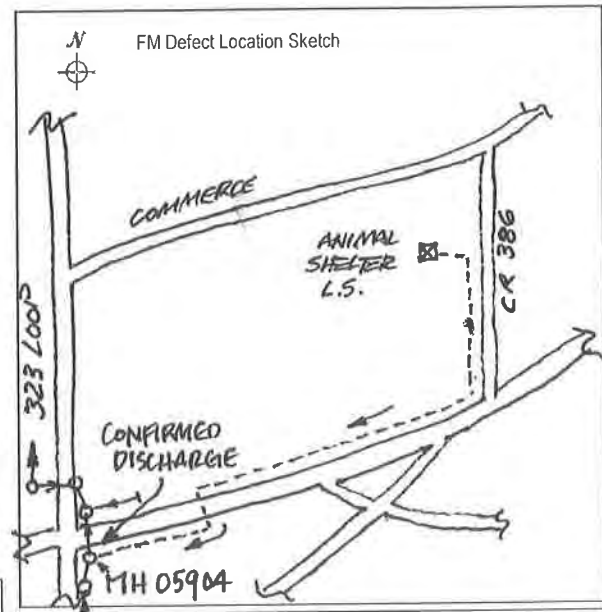
Comments NO ARV'S SHOWN ON PLANS  
WALKED FORCE LINE, NO ARV'S LOCATED.  
NO DEFECTS ALONG SURFACE.  
CONFIRMED DISCHARGE LOCATION PER PLANS.  
AT MH 05904

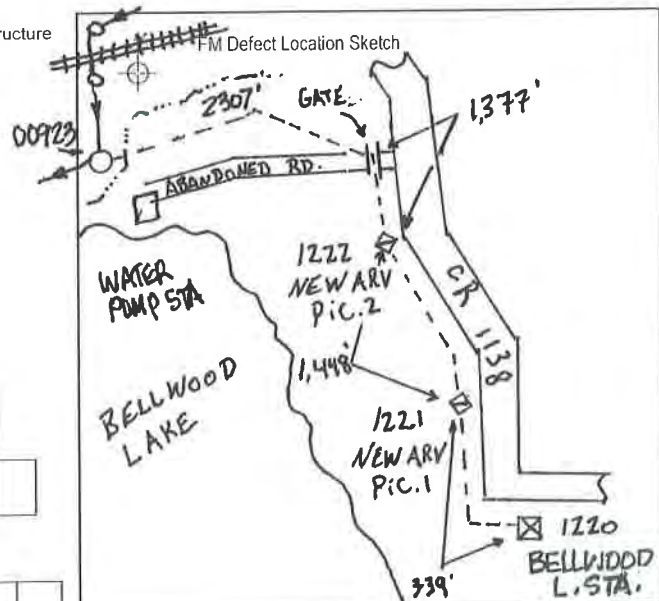
Comments: WALKED FORCE MAIN..  
LOCATED 2 ARV NOT SHOWN ON  
PLANS.

NO SURFACE DEFECTS NOTED.  
CONFIRMED DISCHARGE LOCATION  
AT MH 00923

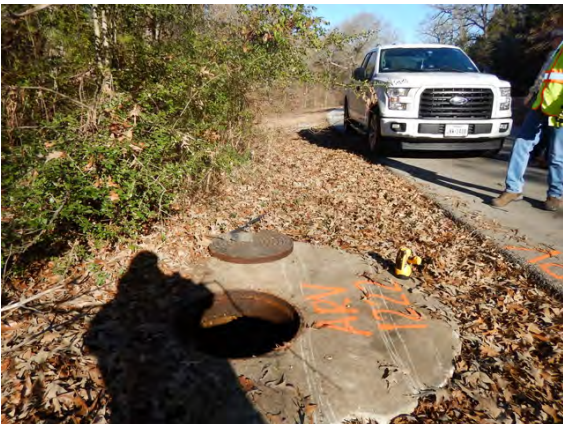
- **Bellwood Force Main:** Two additional ARVs were located in the field which were not a part of the original plans. Both ARVs were located at 10632 CR 1138. ARV 1222 was found to be in poor condition and did not release air when operated.

ARV 1222 Bellwood Area in Good Condition, Manhole Ring in Poor Condition

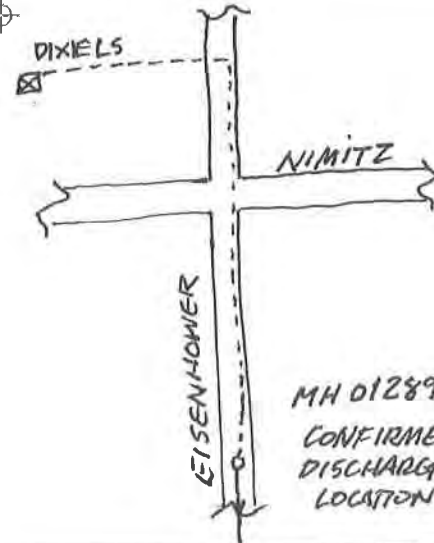
WALKED FORCE LINE.. NO DEFECTS  
LOCATED..  
4" 12IN @ L.STA. 4" PVC AT DISCHARGE.  
CONFIRMED DISCHARGE LOCATION. AS  
SHOWN ON PLANS AT MH 01289  
NO ARV SHOWN ON PLANS  
NONE LOCATED

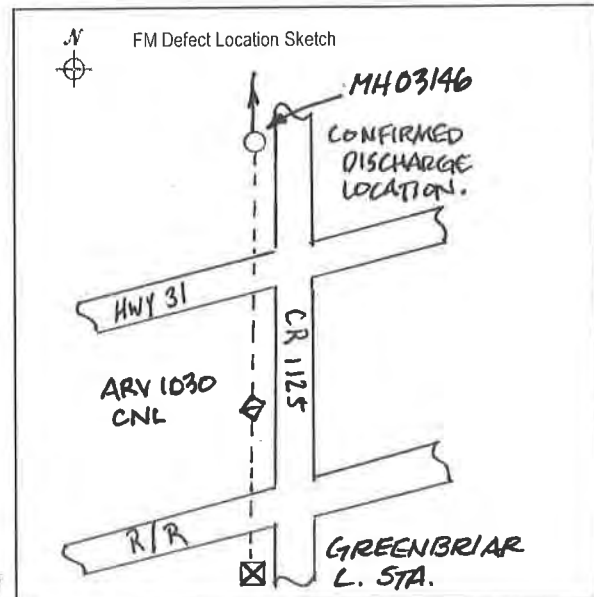
WALKED FORCE MAIN  
NO SURFACE DEFECTS NOTED  
COULD NOT LOCATE ARV 1030  
(METAL DETECTED)  
CONFIRMED DISCHARGE  
LOCATION AS SHOWN ON PLANS  
AT MH 03146

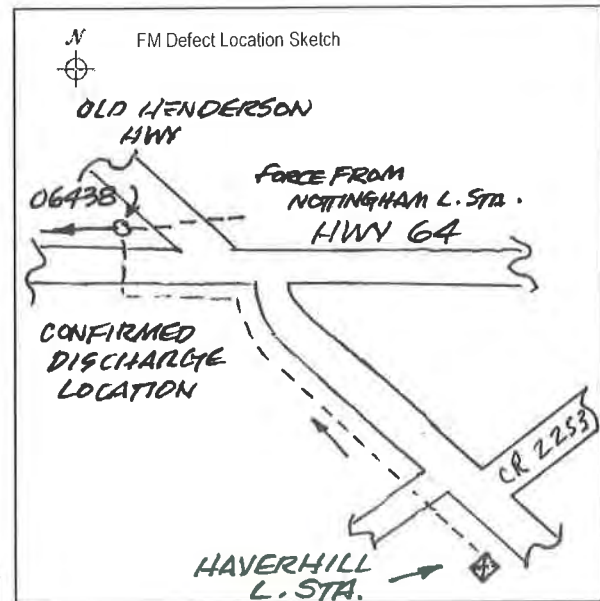
WALKED FORCE MAIN, NO ARV  
LOCATED.

NO SURFACE DEFECTS NOTED.

CONFIRMED DISCHARGE LOCATION  
AT MH 06438

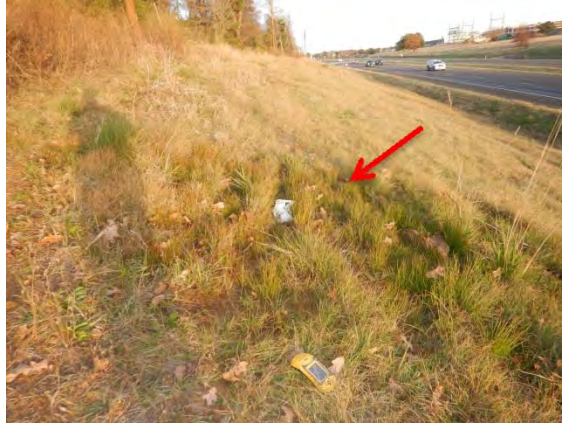
Highway 31 West Wet Spot 243' East of 13838; Leak to needing to be identified

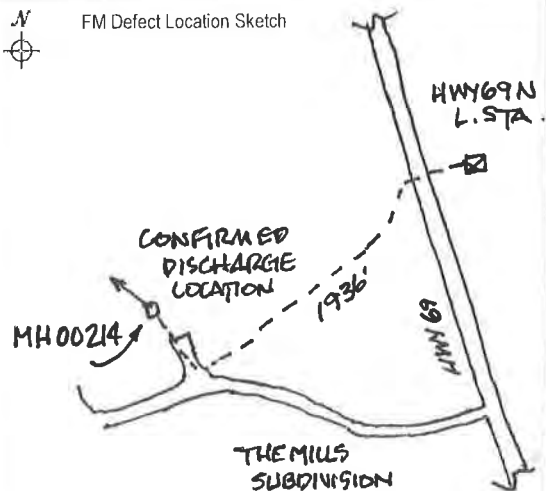
Comments WALKED FORCE LINE, NO ARV SHOWN AND NONE FOUND. NO DEFECTS FROM/ALONG SURFACE NOTED. CONFIRMED 6" PVC FORCE MAIN AT LOCATION PER PLANS AT MH 00214

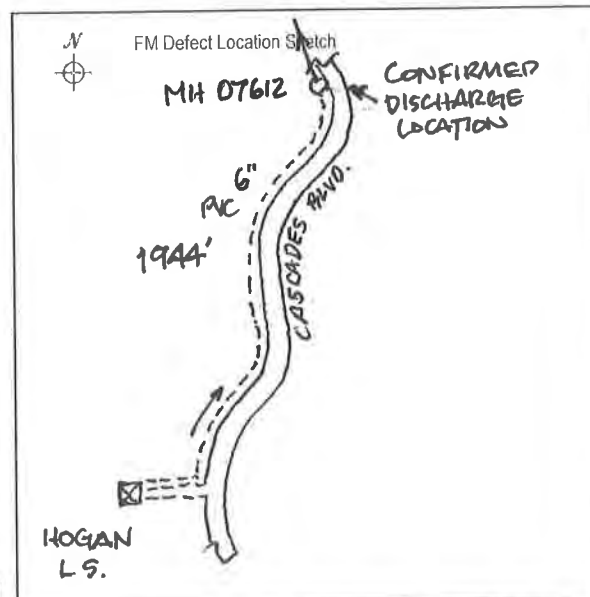
Comments NO ARV'S SHOWN ON PLANS. WALKED FORCE LINE. NO SURFACE DEFECTS NOTED. NO ARV'S LOCATED. CONFIRMED DISCHARGE LOCATION AS SHOWN ON PLANS. AT MH 07612 6 IRON @ LS, 6" PVC @ DISCHARGE MH.

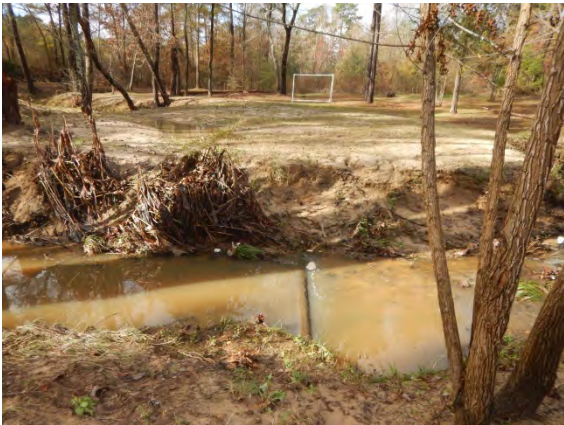
- **Nottingham Lane Force Main:** A section of the force main is exposed at a creek crossing approximately 100 feet west of CR 274 due to surface erosion. No surface defects were noted during the assessment. Minor corrosion was observed on ARV 1350 and the valve did not operate freely.

Nottingham Erosion

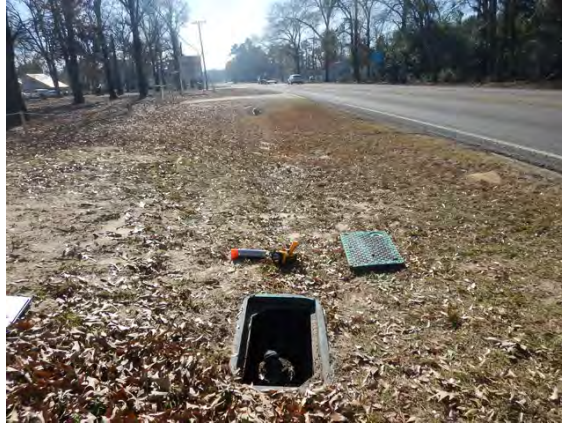
- **Pilot Truck Force Main:** The force main showed no visible defects. Two (2) new ARVs were located at approximately 1220 feet (ARV 1291) and 6368 feet (ARV 1271A) south of the Pilot Truck lift station. ARV 1260 was also located and found to be in critical condition due to corrosion.

ARV 1260 Pilot Area and Vault in Good Condition

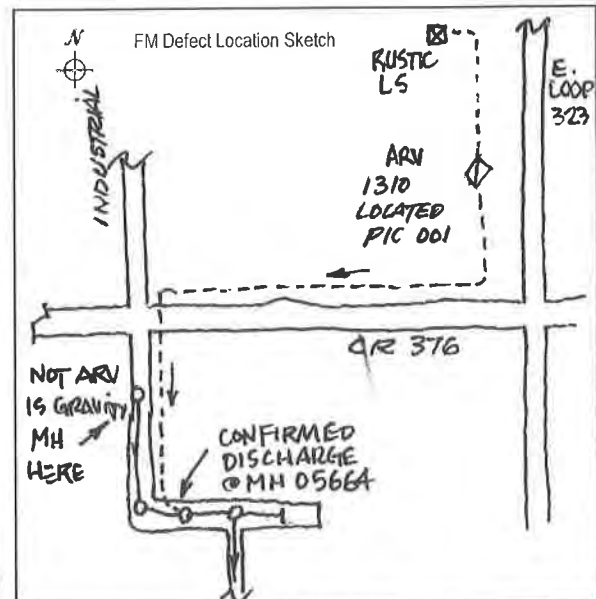
Comments WALKED FORCE LINE LOCATED ARV 1310... ARV 1340 DNE.. THERE IS GRAVITY MH AT THAT LOCATION SHOWN. NO DEFECTS NOTED ALONG FORCE LINE. DISCHARGE CONFIRMED PER PLANS 4" PVC. AT MH 05664

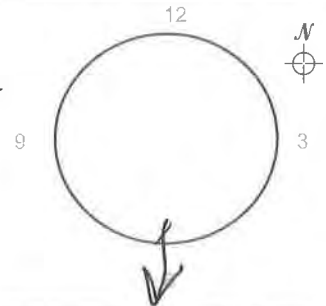
Comments: FORCE LINE VISIBLE IN MH  
4" PVC . DEPTH TO TOP OF PIPE  
MODERATE CORROSION ON ARV PIPE STRAP  
MINOR RUST ON 3 VALVES  
NO MFG./MODEL VISIBLE  
UPPER & MIDDLE VALVES TURN 1/2  
LOWER VALVE SPINS .  
Signature: \_\_\_\_\_  
RUSTIC L. STA.

MH DEPTH: 4.47

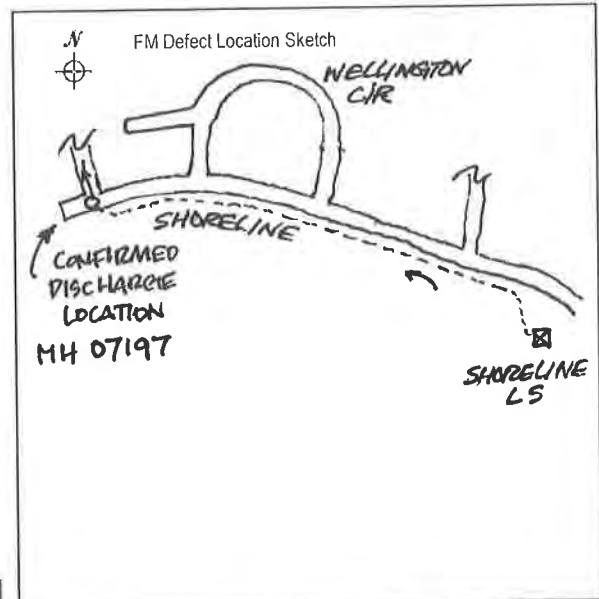
Comments WALKED FORCE LINE, NO ARV SHOWN ON PLANS... NONE LOCATED. NO DEFECTS ALONG FORCE LINE.

CONFIRMED DISCHARGE LOCATION AT MH 07197

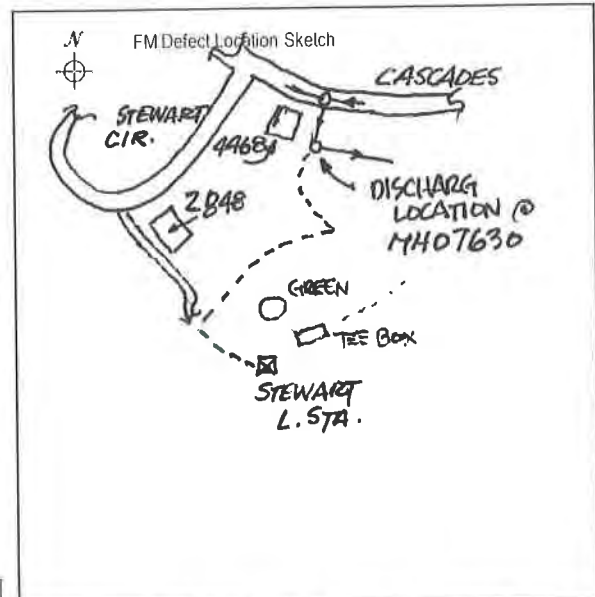
Comments: WALKED FORCE LINE ... NO ARV SHOWN ON PLANS ... NONE LOCATED  
NO SURFACE DEFECTS NOTED  
4" PVC DISCHARGE CONFIRMED AS SHOWN ON PLANS AT MH 07630

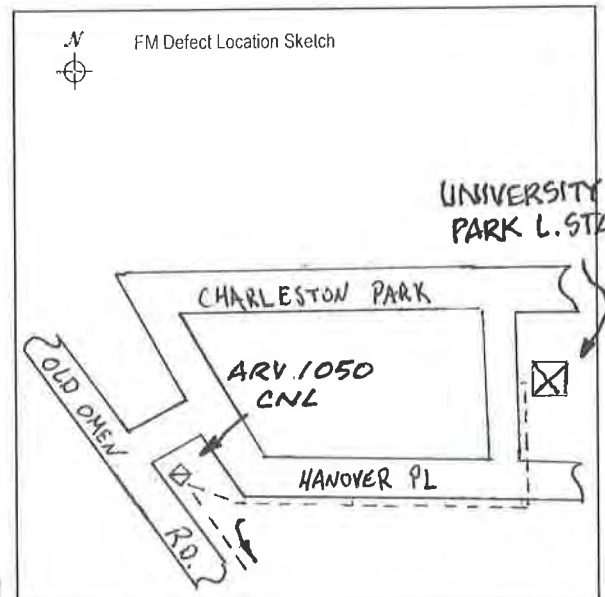
Comments WALKED FORCE MAIN .  
NO SURFACE DEFECT NOTED  
COUL NOT LOCATE ARV 1050  
CONFIRMED DISCHARGE  
LOCATION @ MH 07589

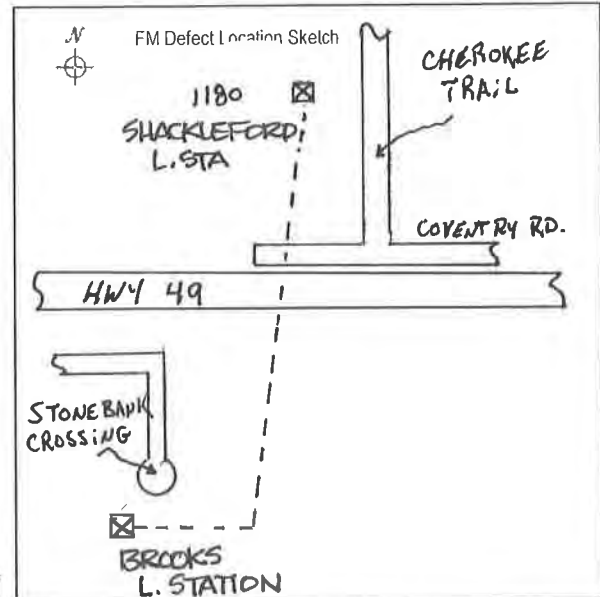
WALKED FORCE MAIN.  
NO ARV LOCATED, NONE SHOWN  
ON PLANS.  
NO SURFACE DEFECTS NOTED.

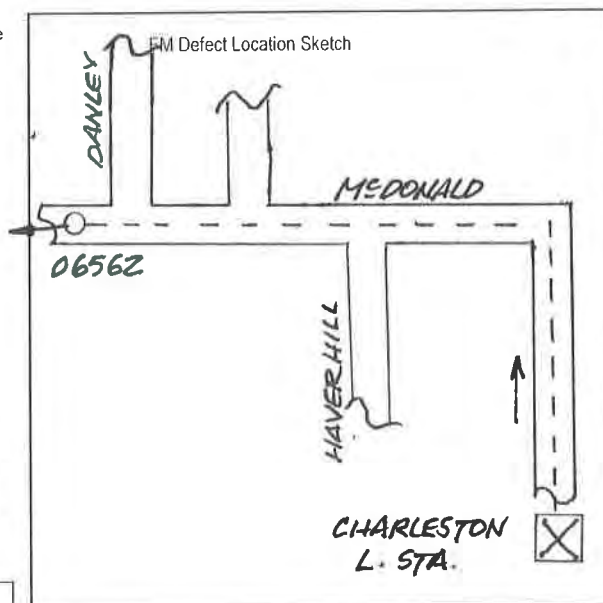
WALKED FORCE MAIN  
NO ARV LOCATED.  
NO SURFACE DEFECTS NOTED  
CONFIRMED DISCHARGE LOCATION  
AT MH 06562 6" PVC

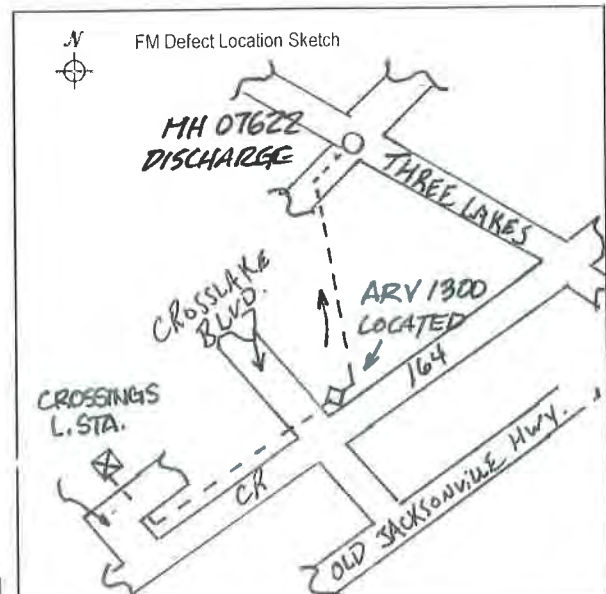
WALKED FORCE MAIN.  
LOCATED ARV 1300 .. FULL OF WATER  
NO SURFACE DEFECTS NOTED.  
CONFIRMED DISCHARGE AT MH  
07622 6" PVC.

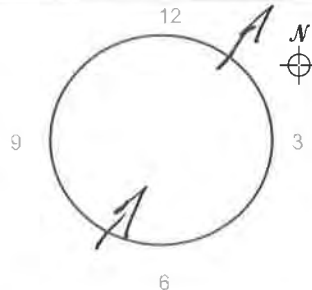
MH SURCHARGED.  
UNABLE TO SEE  
PIPE OR VALVES

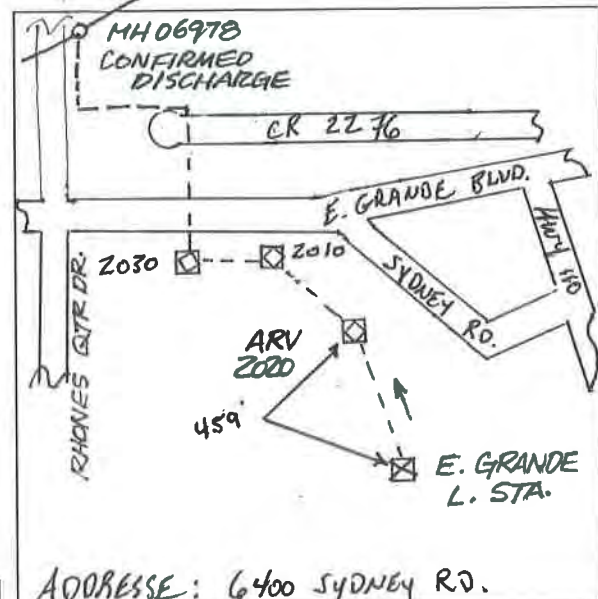
Comments **WALKED FORCE MAIN  
LOCATED ARV 2020... DID NOT FIND  
2010 OR 2030.. METAL DETECTED.**

NO SURFACE DEFECTS NOTED.  
CONFIRMED DISCHARGE  
LOCATION AT MH 06978

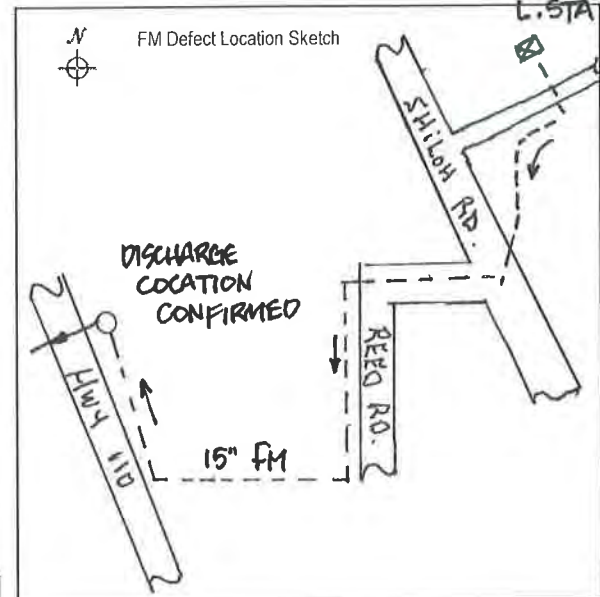
NO SURFACE DEFECTS NOTED.  
NO ARV SHOWN & NONE FOUND.  
CONFIRMED DISCHARGE LOCATION  
AS ON PLAN MH 07667

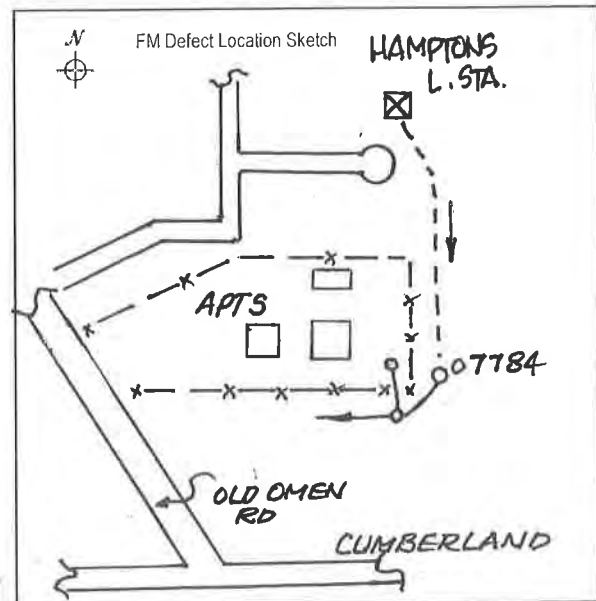
Comments: **WALKED FORCE MAIN**  
**NO ARV SHOWN NOR LOCATED.**  
**COULD NOT CONFIRM DISCHARGE**  
**LOCATION... CNL MH**  
**PLAN SHOWS DISCHARGE AT**  
**MH 07784 BUT COULD NOT LOCATE**

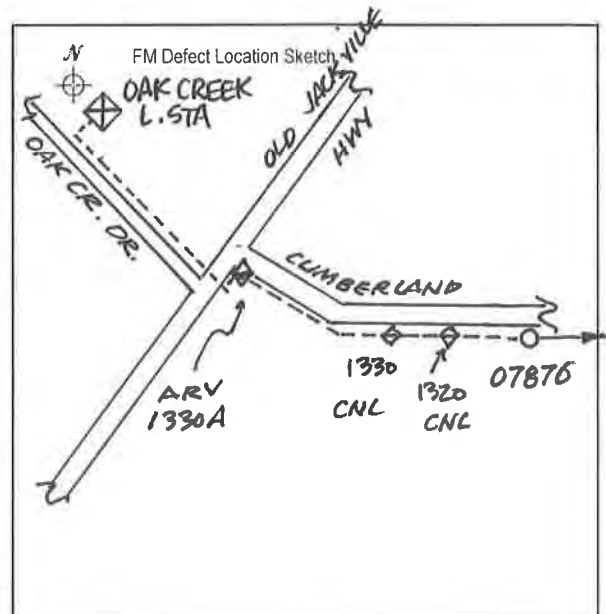
Comments WALKED FORCE MAIN  
LOCATED 1 ARV NOT SHOWN ON MAP.  
ARV'S 1320 & 1330 NOT LOCATED.  
NO SURFACE DEFECTS NOTED.  
CONFIRMED DISCHARGE AT  
M14 07876

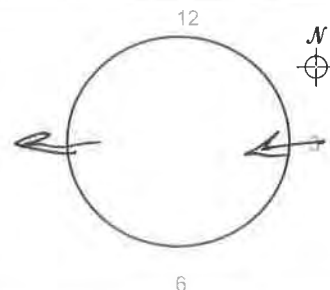
UNABLE TO  
SEE PIPES,

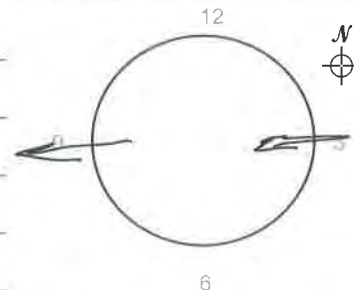
UNABLE TO  
SEE PIPES

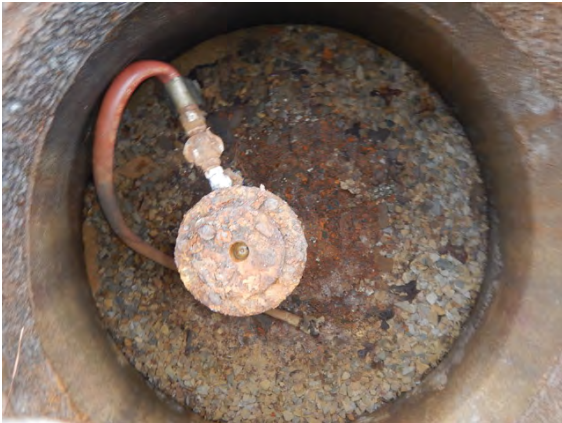
ARV 1230 Shackleford Force Main not Visible in Manhole; Minor Rust on Top and Middle Valve Opening Half Way, Moderate Rust on Lower Valve and Only Spins

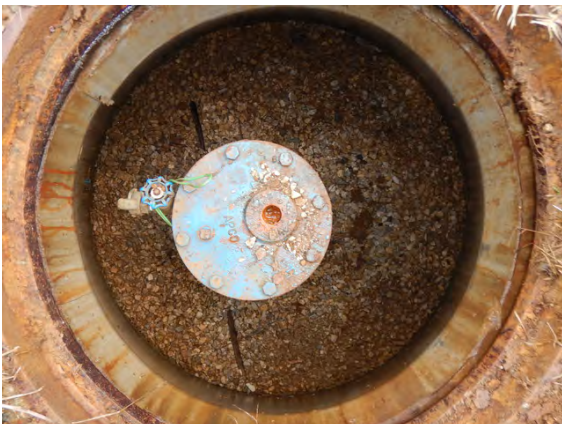
ARV 1231 Shackleford Force Main not Visible in Manhole; Top, Middle and Lower Valve Open to ½ Turn and Released Air
