## SHORELINE LIFT STATION

# Tyler Water Utilities - Lift Station Assessment Form

Lift Station Name SHORELINE Type Submersible  
 Location/Address 4588 Cascade Shoreline Drive  
 Lift Station Asset ID \_\_\_\_\_ Number of Pumps 2  
 Firm Capacity in GPM (all pumps operating) \_\_\_\_\_  
 Firm Capacity in GPM (largest pump out of service) \_\_\_\_\_  
 Inspector Don White Date Dec 17, 2017  
 City Works Work Order \_\_\_\_\_

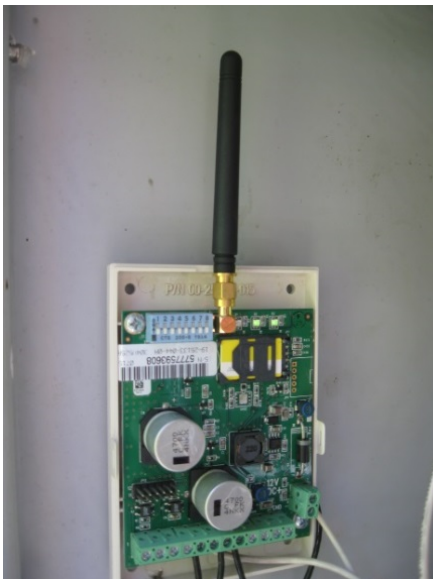
Antenna in Instrumentation Panel
